Corrib Gas Development

Report for PMC Meeting Dated 11th January 2006

Bellanaboy Bridge Site

Report to the Project Monitoring Committee

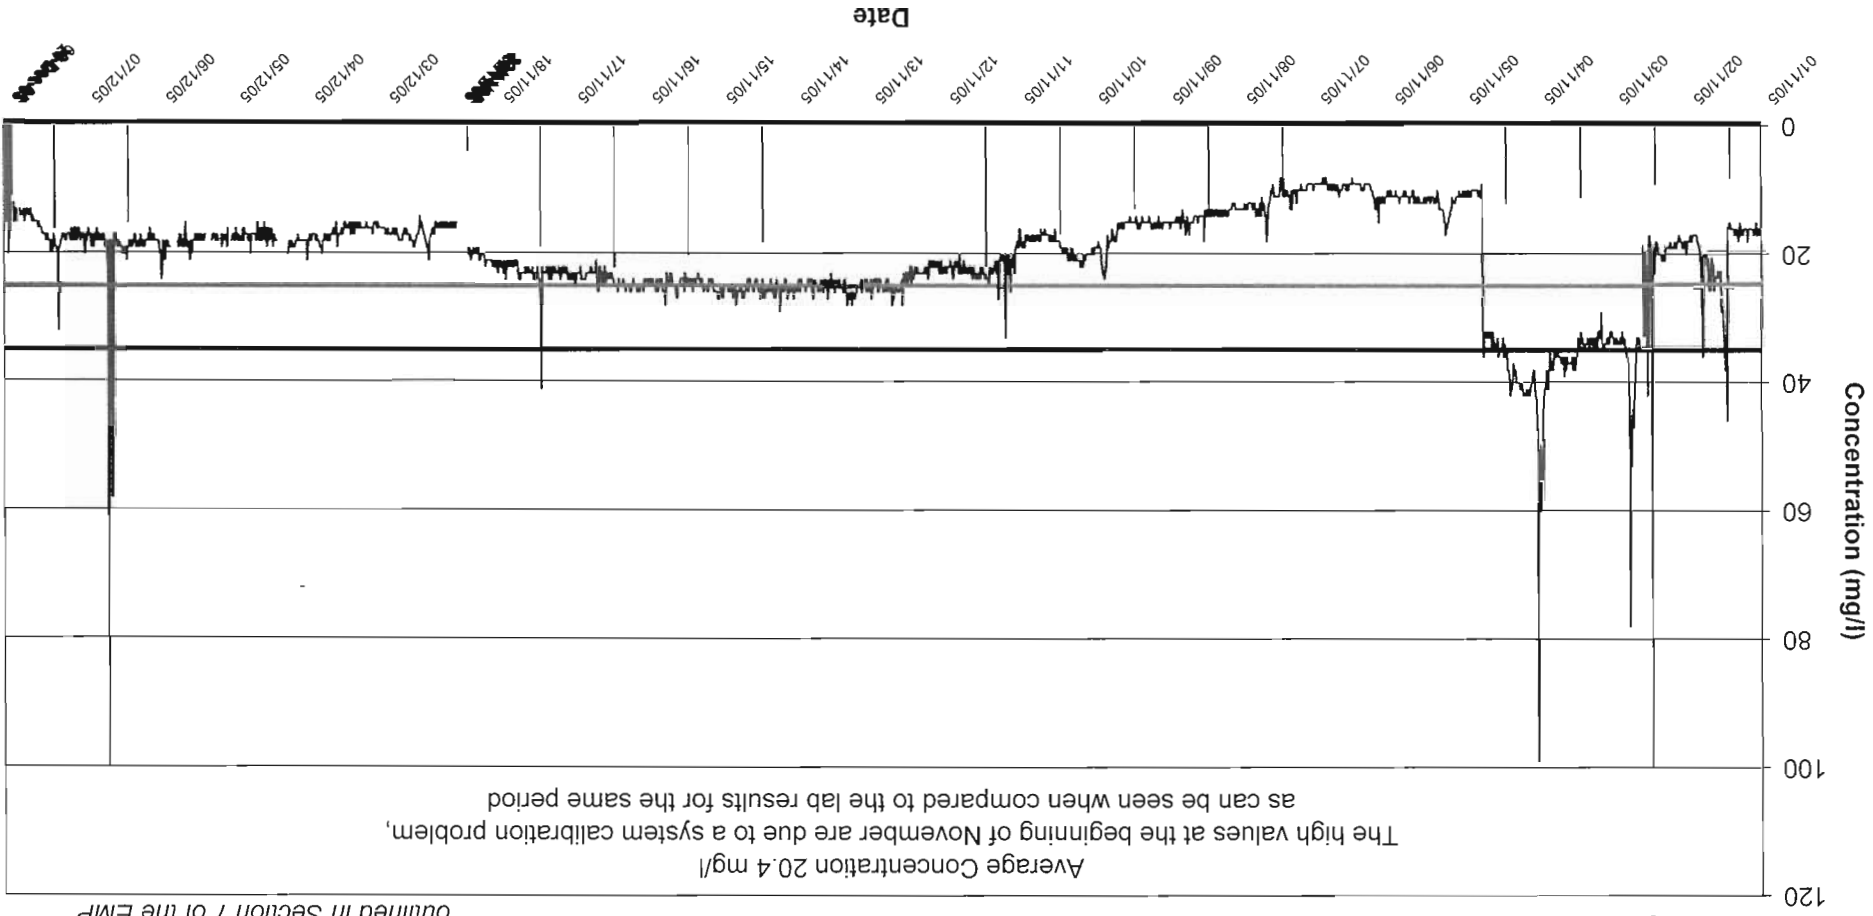
Total Suspended Solids Results at SP1 for Nov/Dec 2005

Incident No. 1: The ISS action level (25mg/l) was exceeded on the 12th November at 13.00. This was due to mineral rich water from the terminal footprint making its way into the surface water drainage system. The water in the southern section of the terminal footprint was then recirculated into the north eastern part of the footprint.

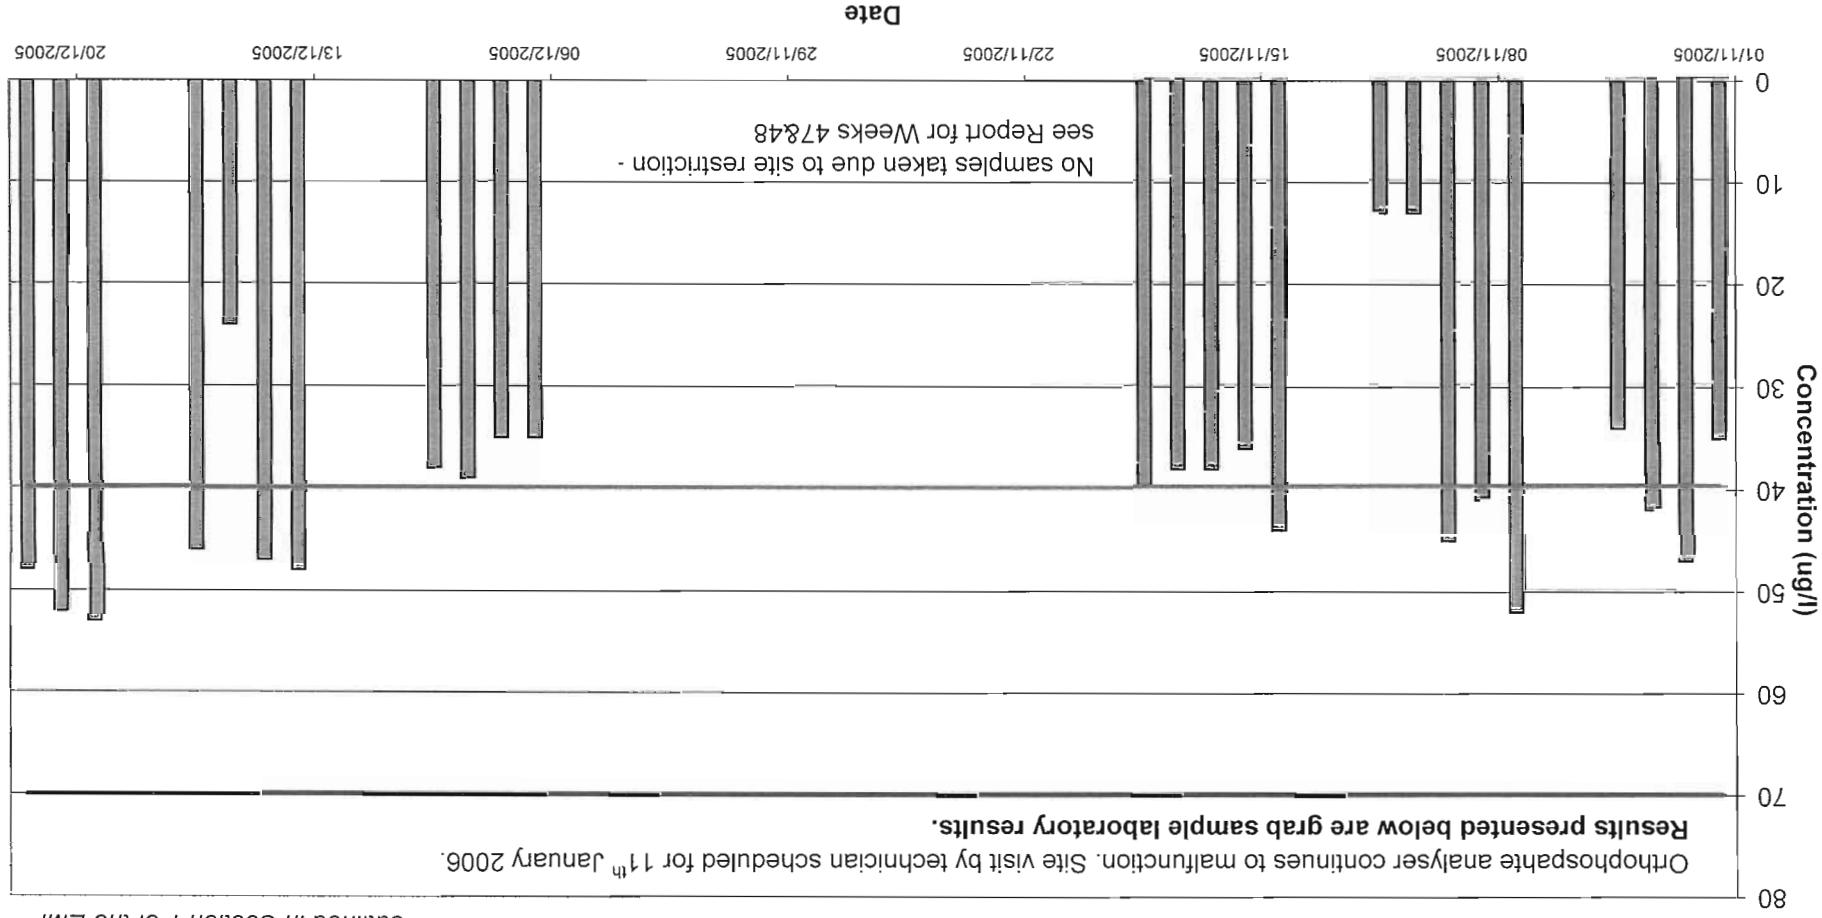
Orthophosphate Results at SP1 for Nov/Dec 2005

Incident No. 2: Equipment Failure – The PO_4 analyser started to produce negative results. The results were forwarded to the manufacturer for review.

Near Miss: The phosphate (PO4) action limit was exceeded.
