CORRIB GAS DEVELOPMENT

Report for PMC (Terminal) Meeting on 12th November 2014.

Bellanaboy Bridge Terminal Site

Report to the Project Monitoring Committee

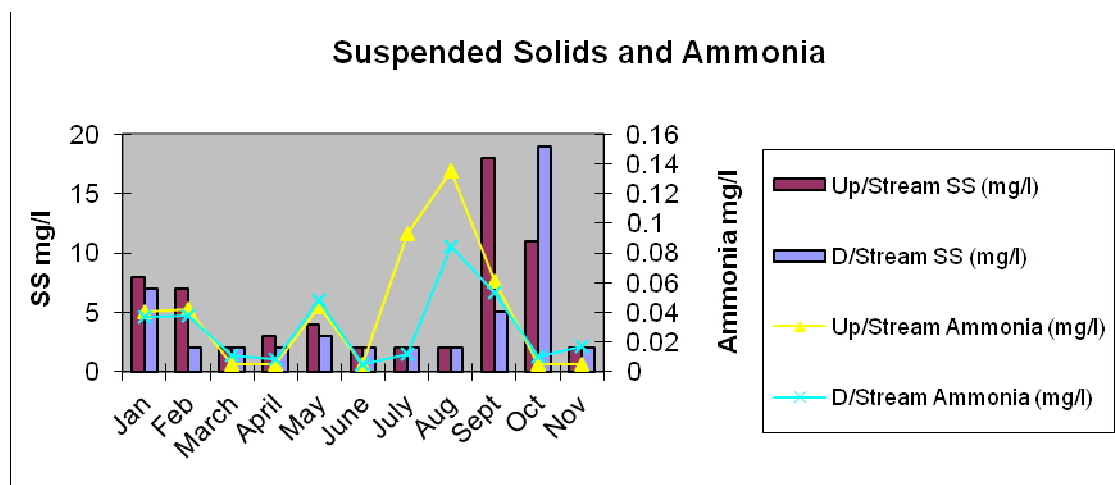
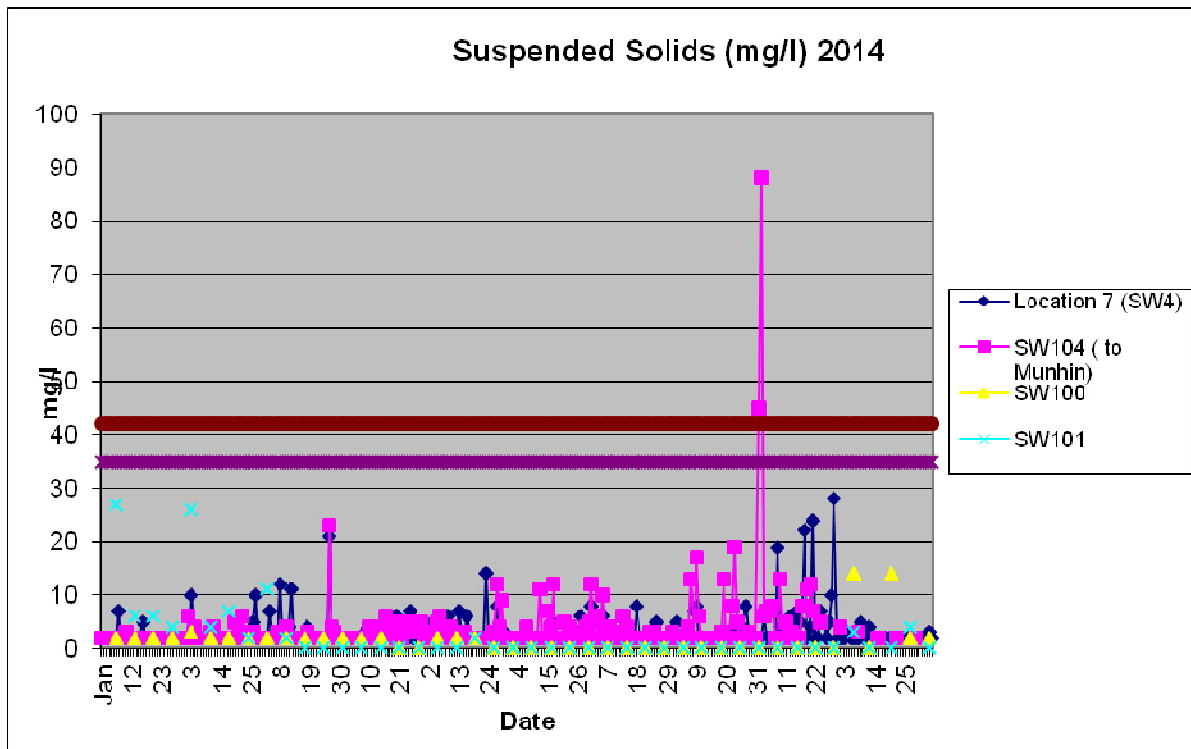
Munhin River (2014)

The average Suspended Solids for 2014 to date was 3.09 mg/l at SW 4 and 3.71 mg/l at the discharge from the site to the Munhin at SW104, and 1.56 and 2.36 mg/l at SW100 and 101.

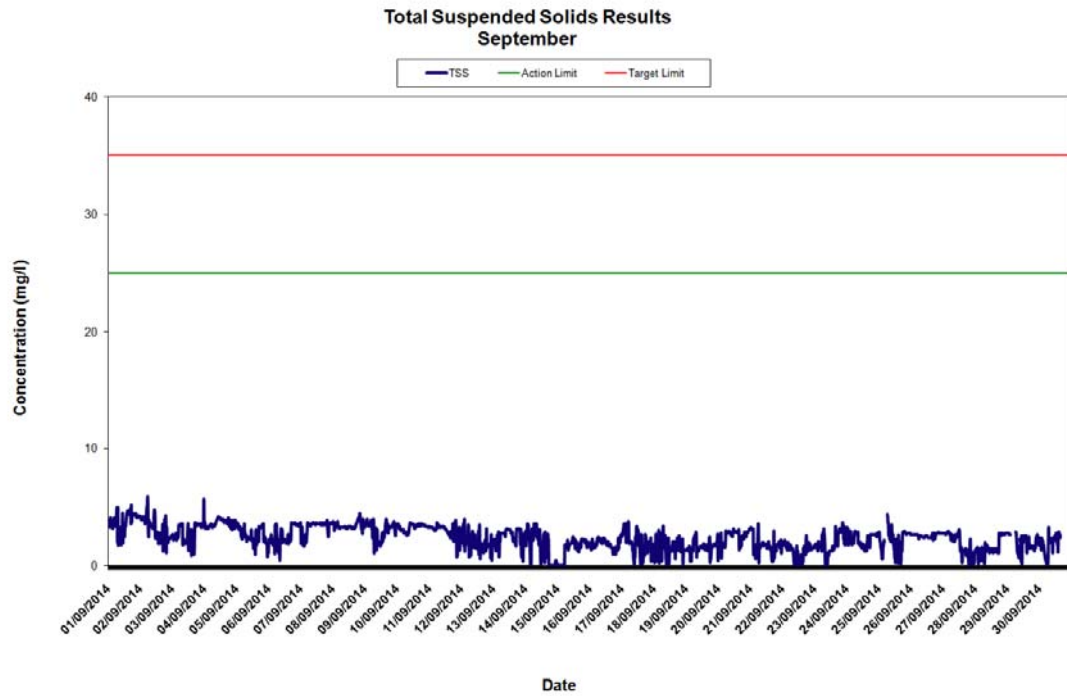
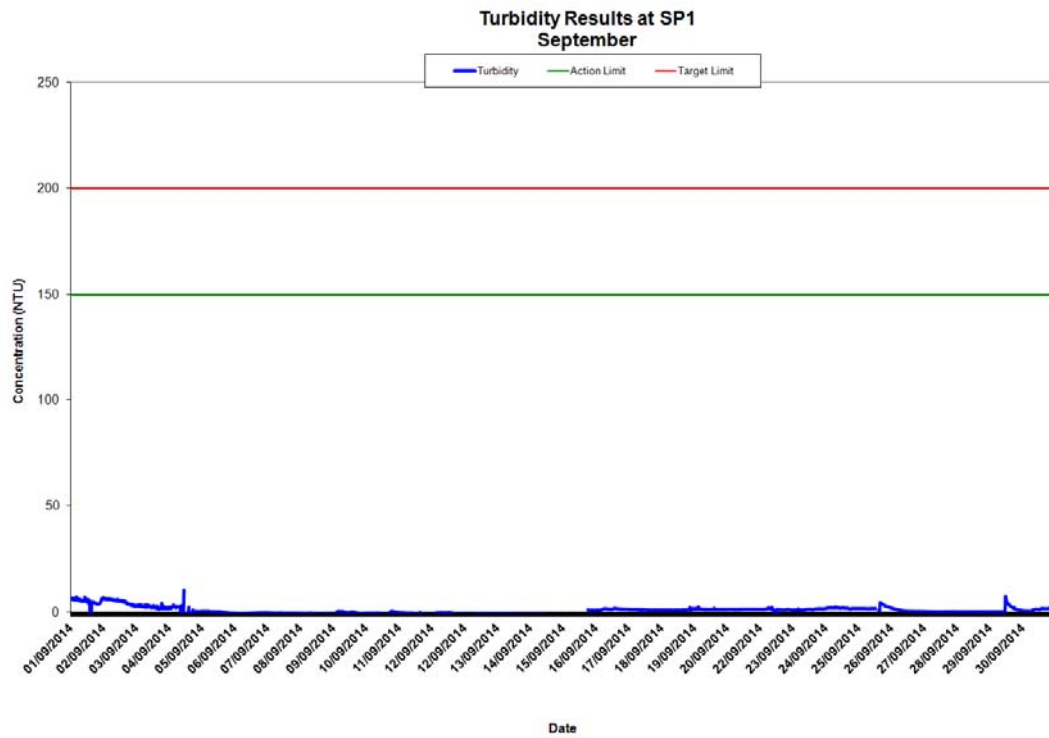
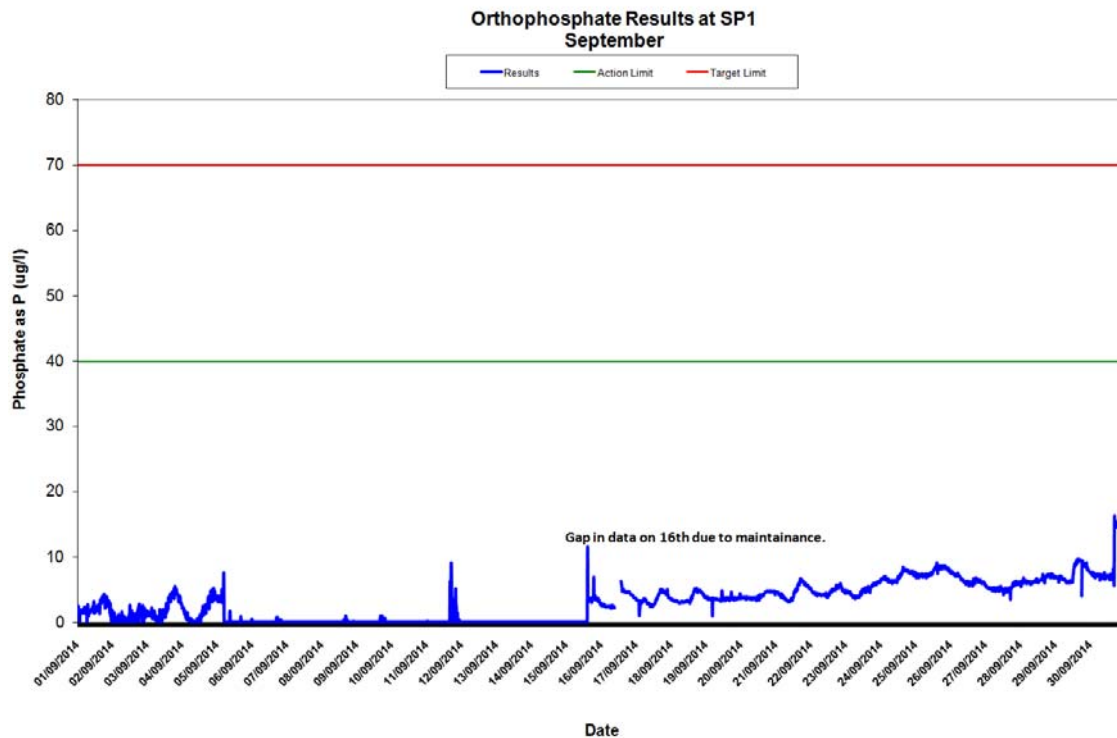
September Graphs

Total Suspended Solids: The TSS graphs for September and October are displayed below. Spikes in the chart are evident during periods of heavy rainfall.

Turbidity: All values for September and October are all lower than the action limit.

Orthophosphate: The results yielded for September and October were below the action limit.
