Corrib Gas Pipeline Environmental Report	Period Ending:	30th November 2011
Compiled By:	Siobhan Sheridan & Carmel Carey	
Approved By:	Aoife Reynolds

Corrib Onshore Pipeline
Monthly Archaeological Report
Aughoose Site

Month Ending: 30th November 2011

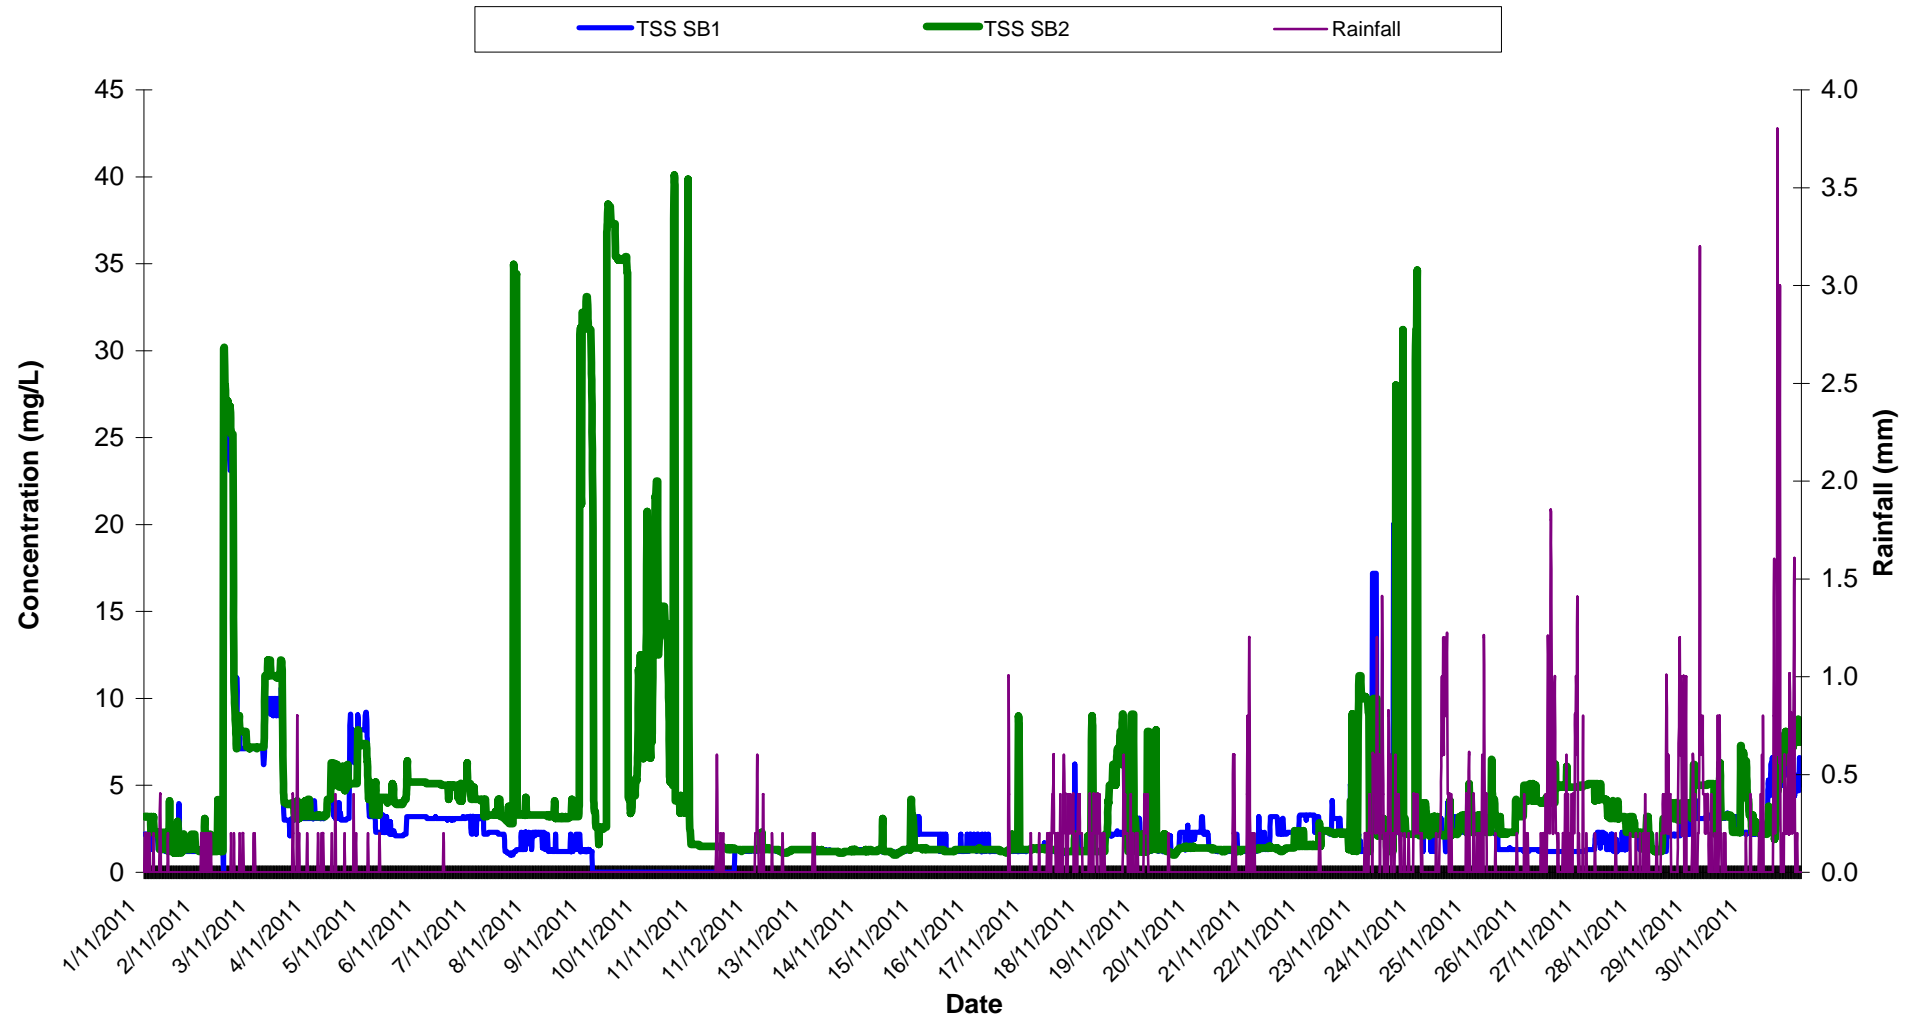
Total Suspended Solids November 2011

Environment	Comments
Vibration	There were times where high levels of vibration was recorded. This was due to works being carried out in the vicinity of vibration meter on 29/11/11 and electrical interferences.
Weather	There was a total of 172.8mm of rainfall during the reporting period, with a temperature range of 1.3°C to 15.5°C
Noise	There have been ongoing power and technical issues in relation to noise meters which are currently being resolved.
Surface Water	There were no surface water exceedences during the month. There were no composite samples available between 7 th and 13 th due to a dry period of weather resulting in insufficient amount of flow through siltbuster. Due to a

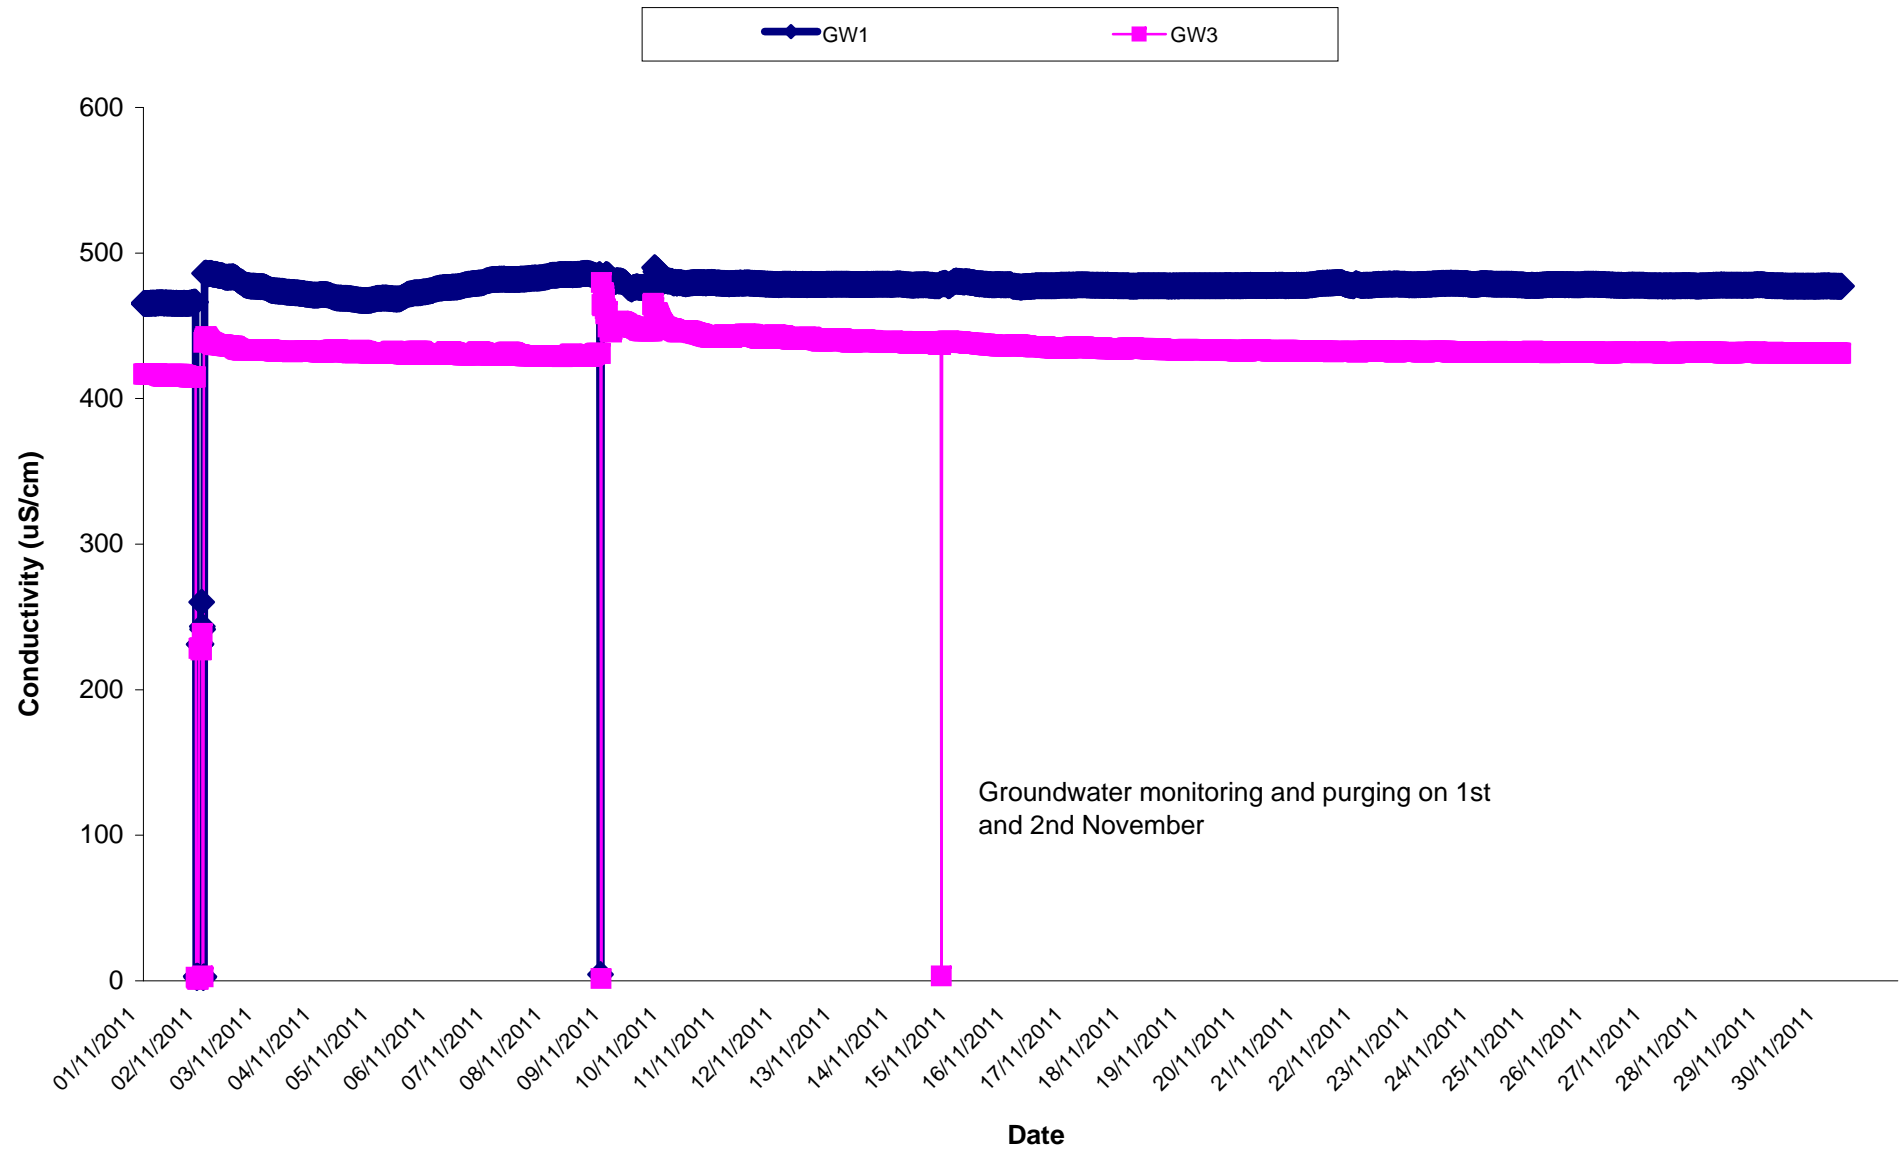
Conductivity - Groundwaters November 2011

Environment	Comments
	power issue with the composite samplers, there were no samples available on 25 th , 26 th and 27 th November.
Groundwater Monitoring	Monitoring of groundwater undertaken during the reporting period does not show any unusual results.

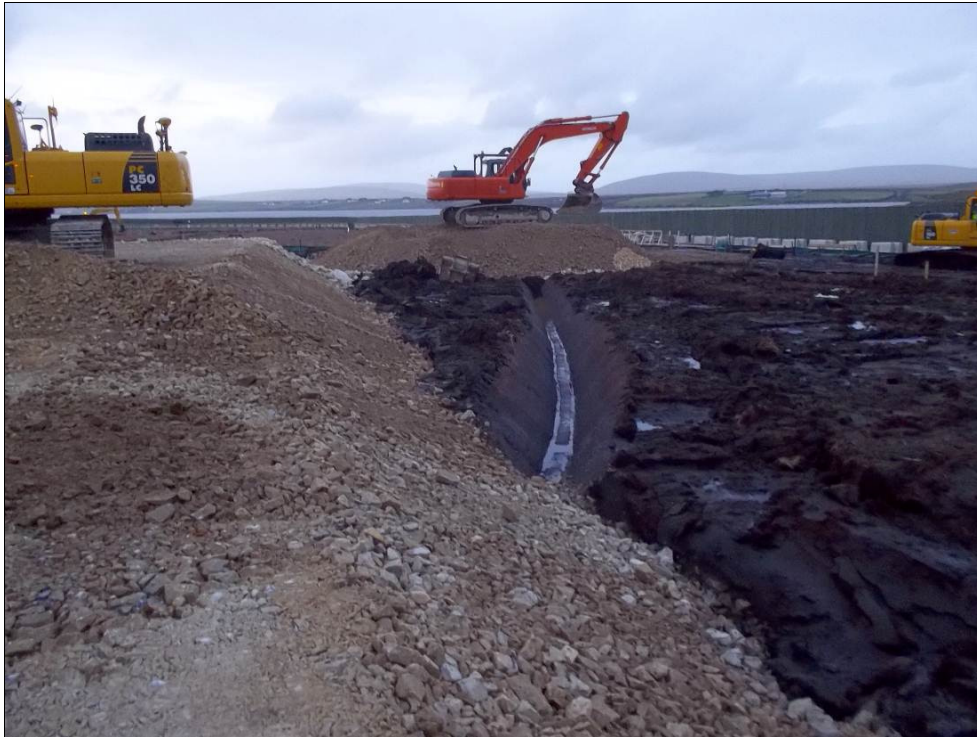
- The construction of further v-ditches to assist drainage and link to the existing network of lagoons/silt ponds, in advance of future works continued (Plate 1).
- The removal of the surface vegetation of peat into turves, this enabled its transport and safe storage. This activity took place in advance of the main site access road works (Plate 2).
- The bulk excavation of peat to facilitate the construction of the next phase of the main site access road and new compound area (Plate 3).
- Bulk excavation of peat for both the northeast and northwest shear keys was carried out, with a peat stone matrix employed as part of the construction of each shear key (between 0.30m and 0.50m of peat was left *in situ* at the base of the excavation) (Plate 4 and 5).
- Auxiliary temporary drainage works (Plate 6).

Plate 1: V-ditch at north-eastern end of new compound area, facing northwest

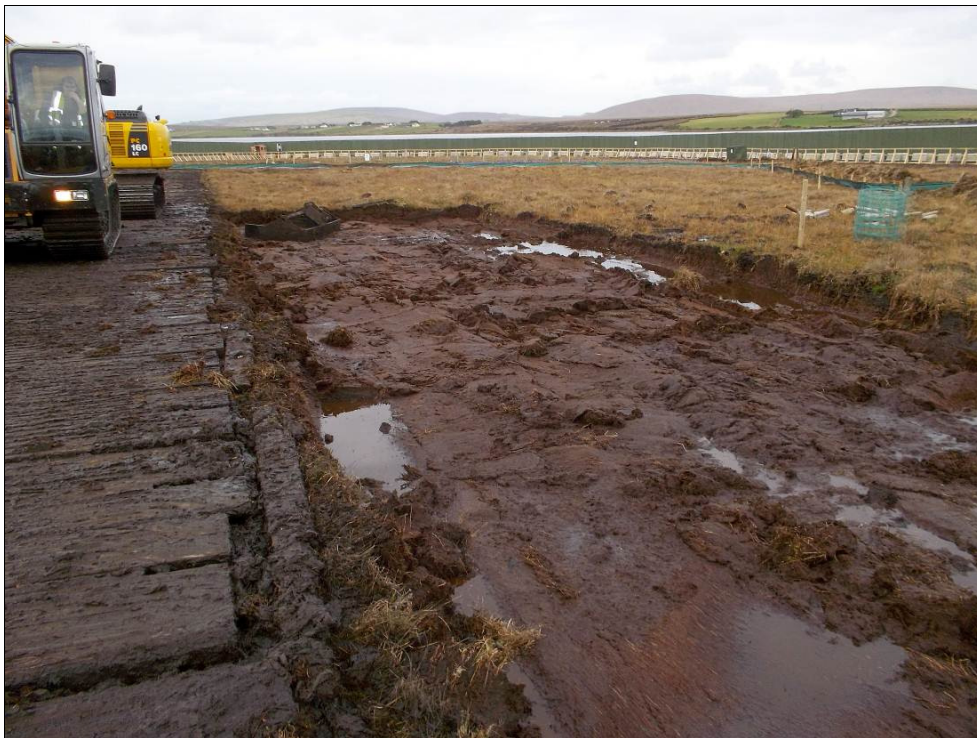
Plate 2: Turving, central area of site, facing west-northwest

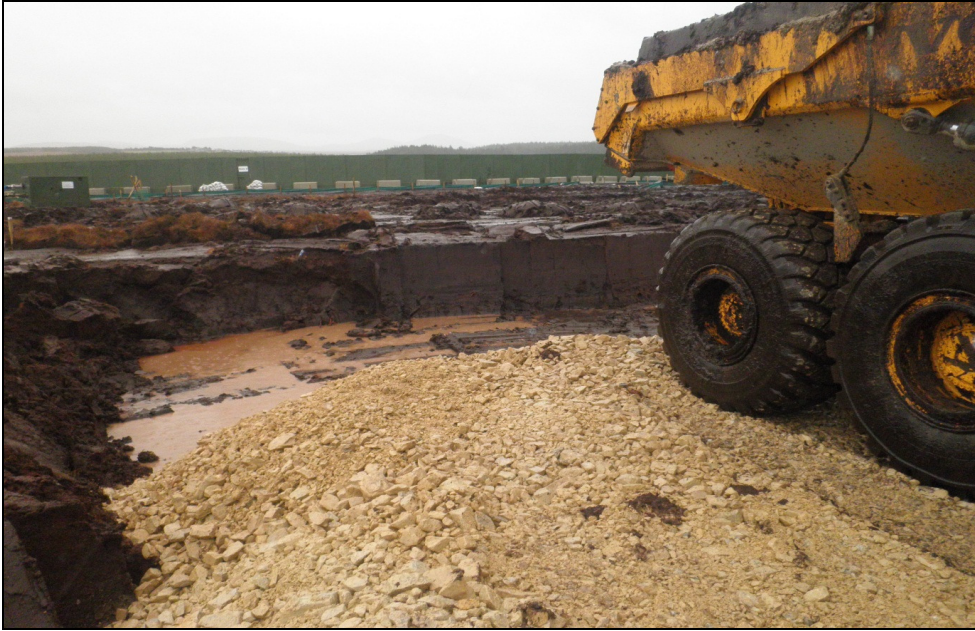
Plate 3: Backfilling of main compound excavation, facing north.

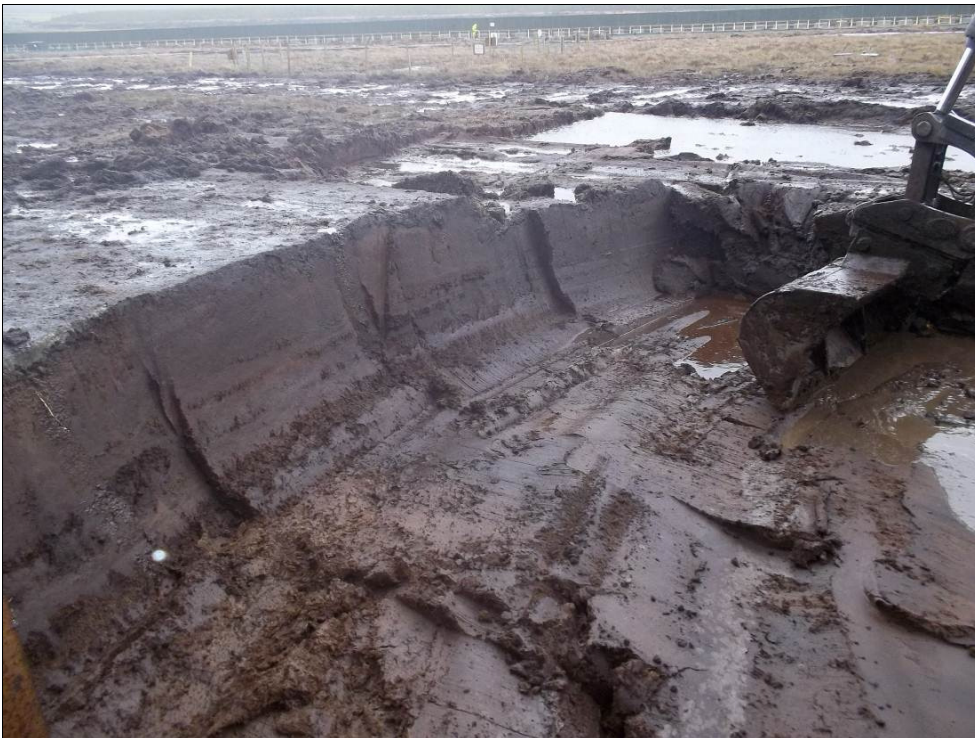
Plate 4: North-west shear key excavation, facing north

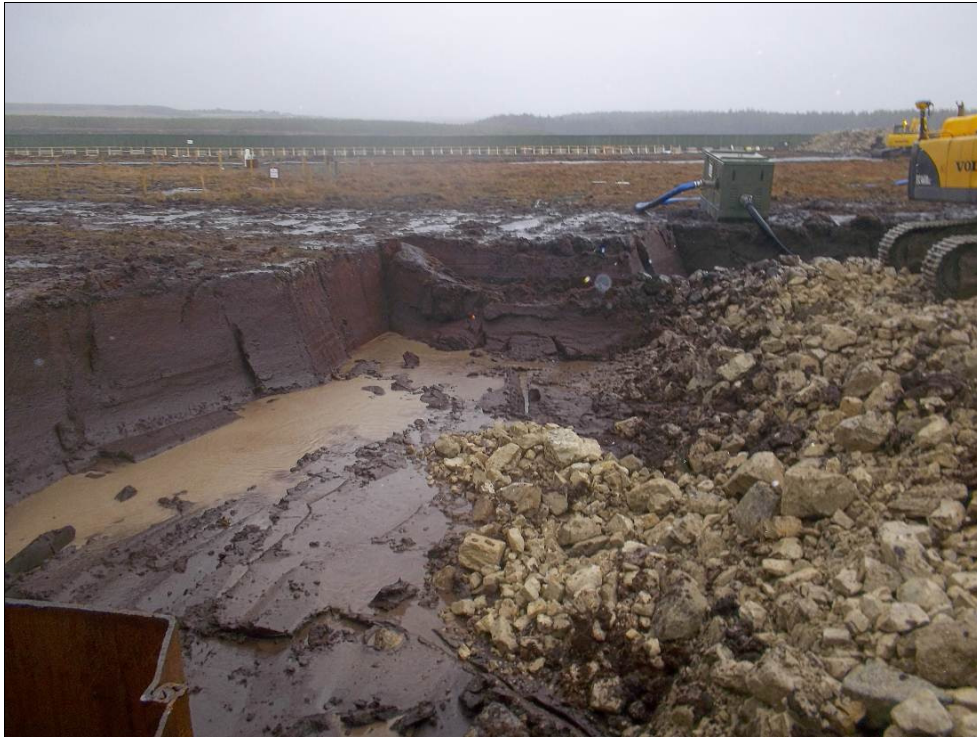
Plate 5: Continuation of north-west shear key excavation, facing north. Note peat became deeper and less stable as excavation progressed to the northwest.

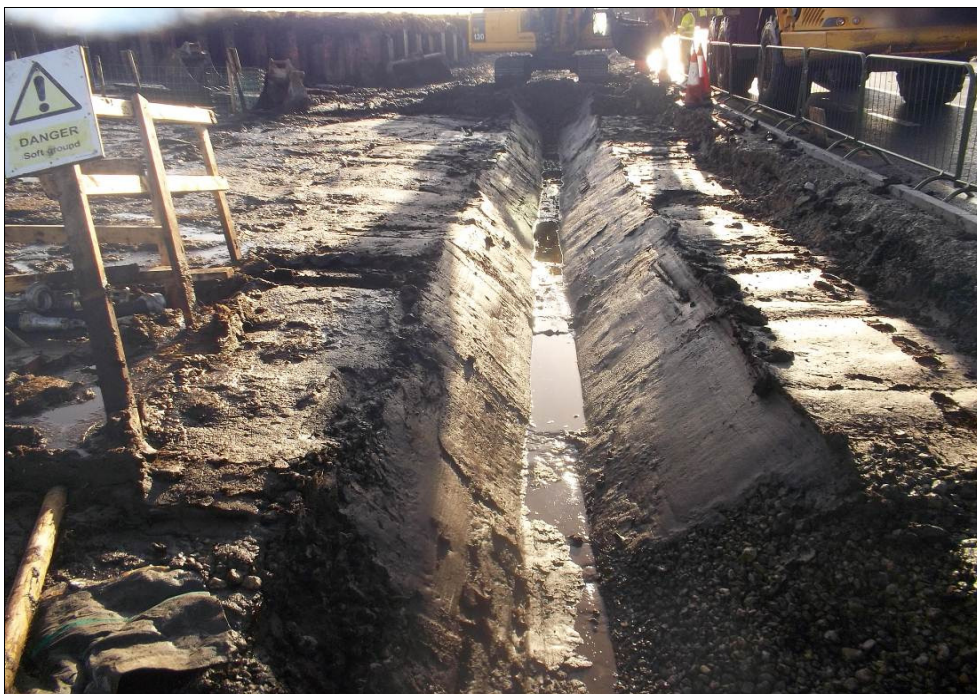
Plate 6: Drain excavation on northern side of access road, facing southwest.

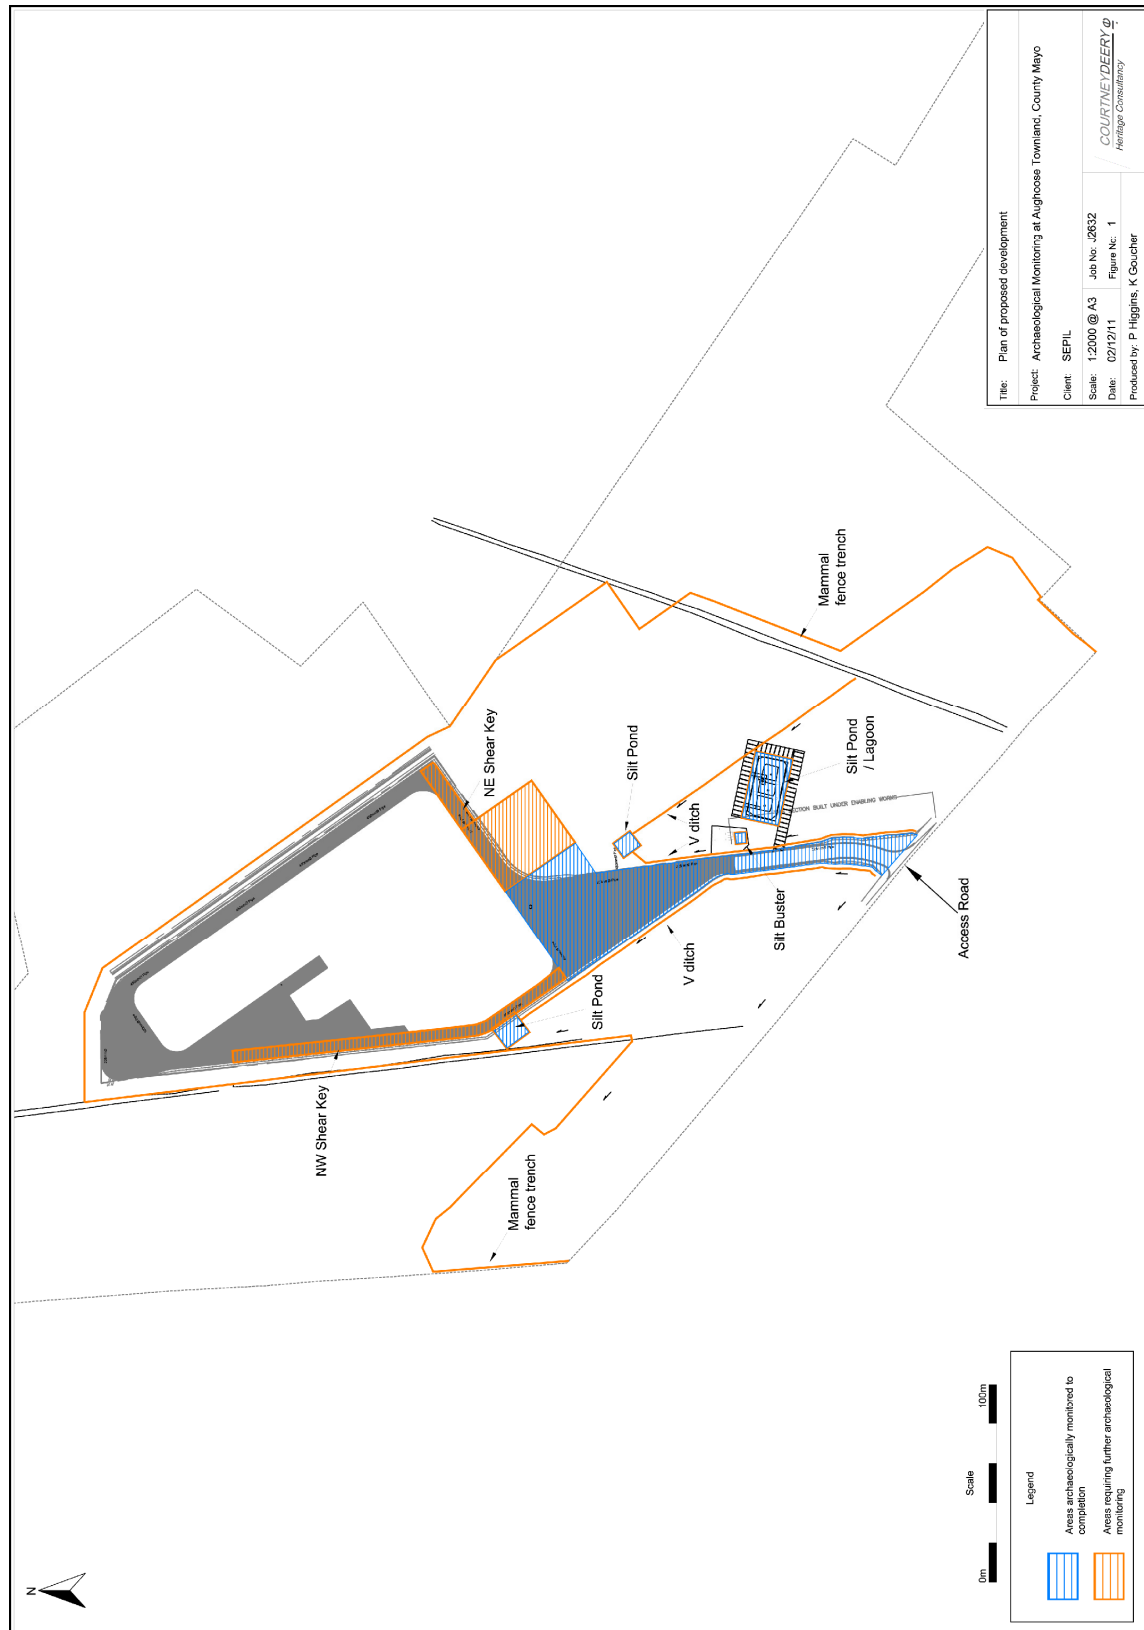
Construction works were carried out on several areas of the Aughoose site these were monitored under strict archaeological supervision (Plate 1-7). These works (Figure 1) comprised:
