A GUIDE TO THE REPAIR OF THATCHED ROOFS

An Roinn
Ealaíon, Oidhreachta agus Gaeltachta
Department of
Arts, Heritage and the Gaeltacht

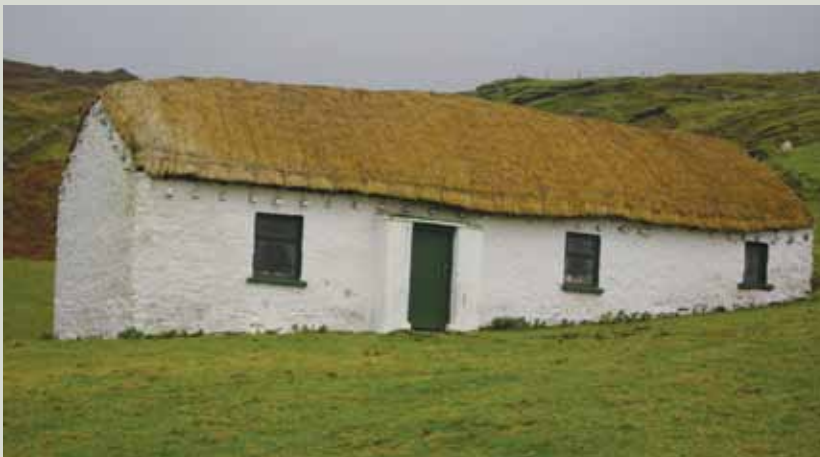
An example of roped thatch from County Donegal – a method of construction developed in response to the high winds experienced along the exposed Atlantic coast

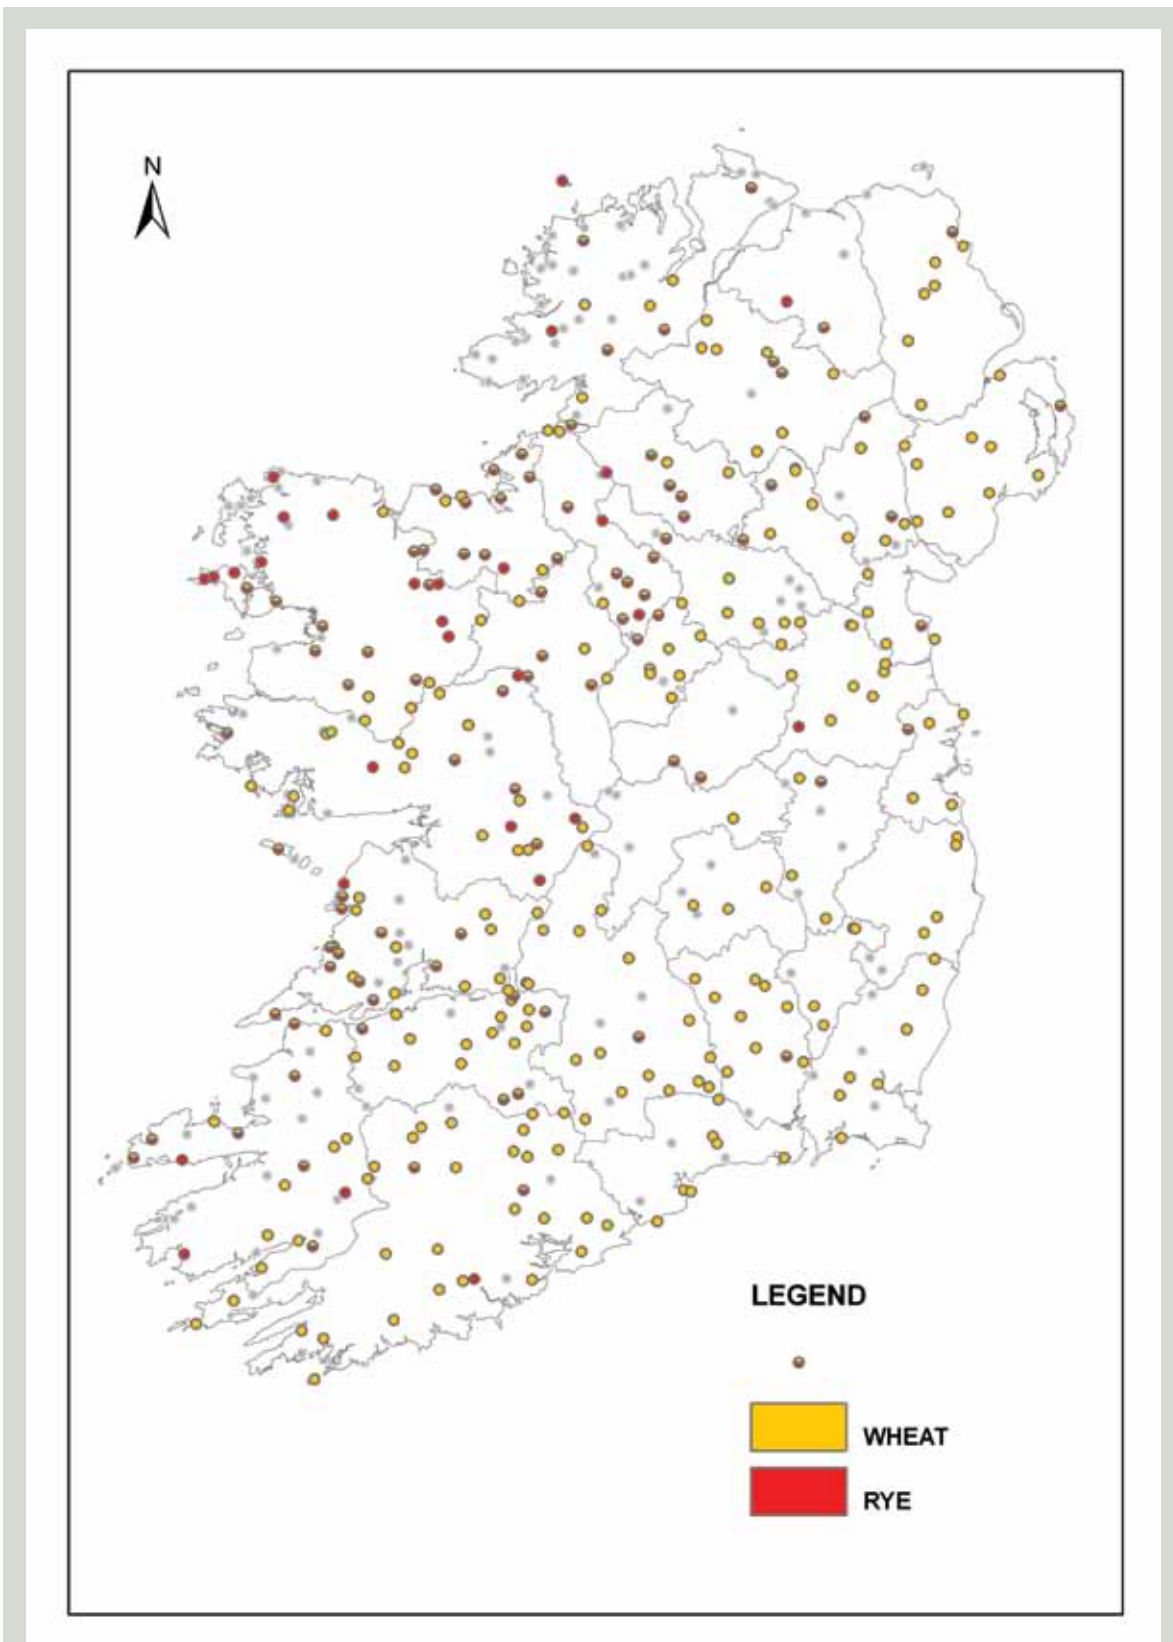
In 1945, over much of Ireland, wheat was preferred for thatch because of its durability. Its distribution is most pronounced in the traditionally intensive cereal-growing districts of the south and east. The cultivation of rye specifically for thatching, a cereal better suited to lighter, less fertile soils, was common in the western half of Ireland

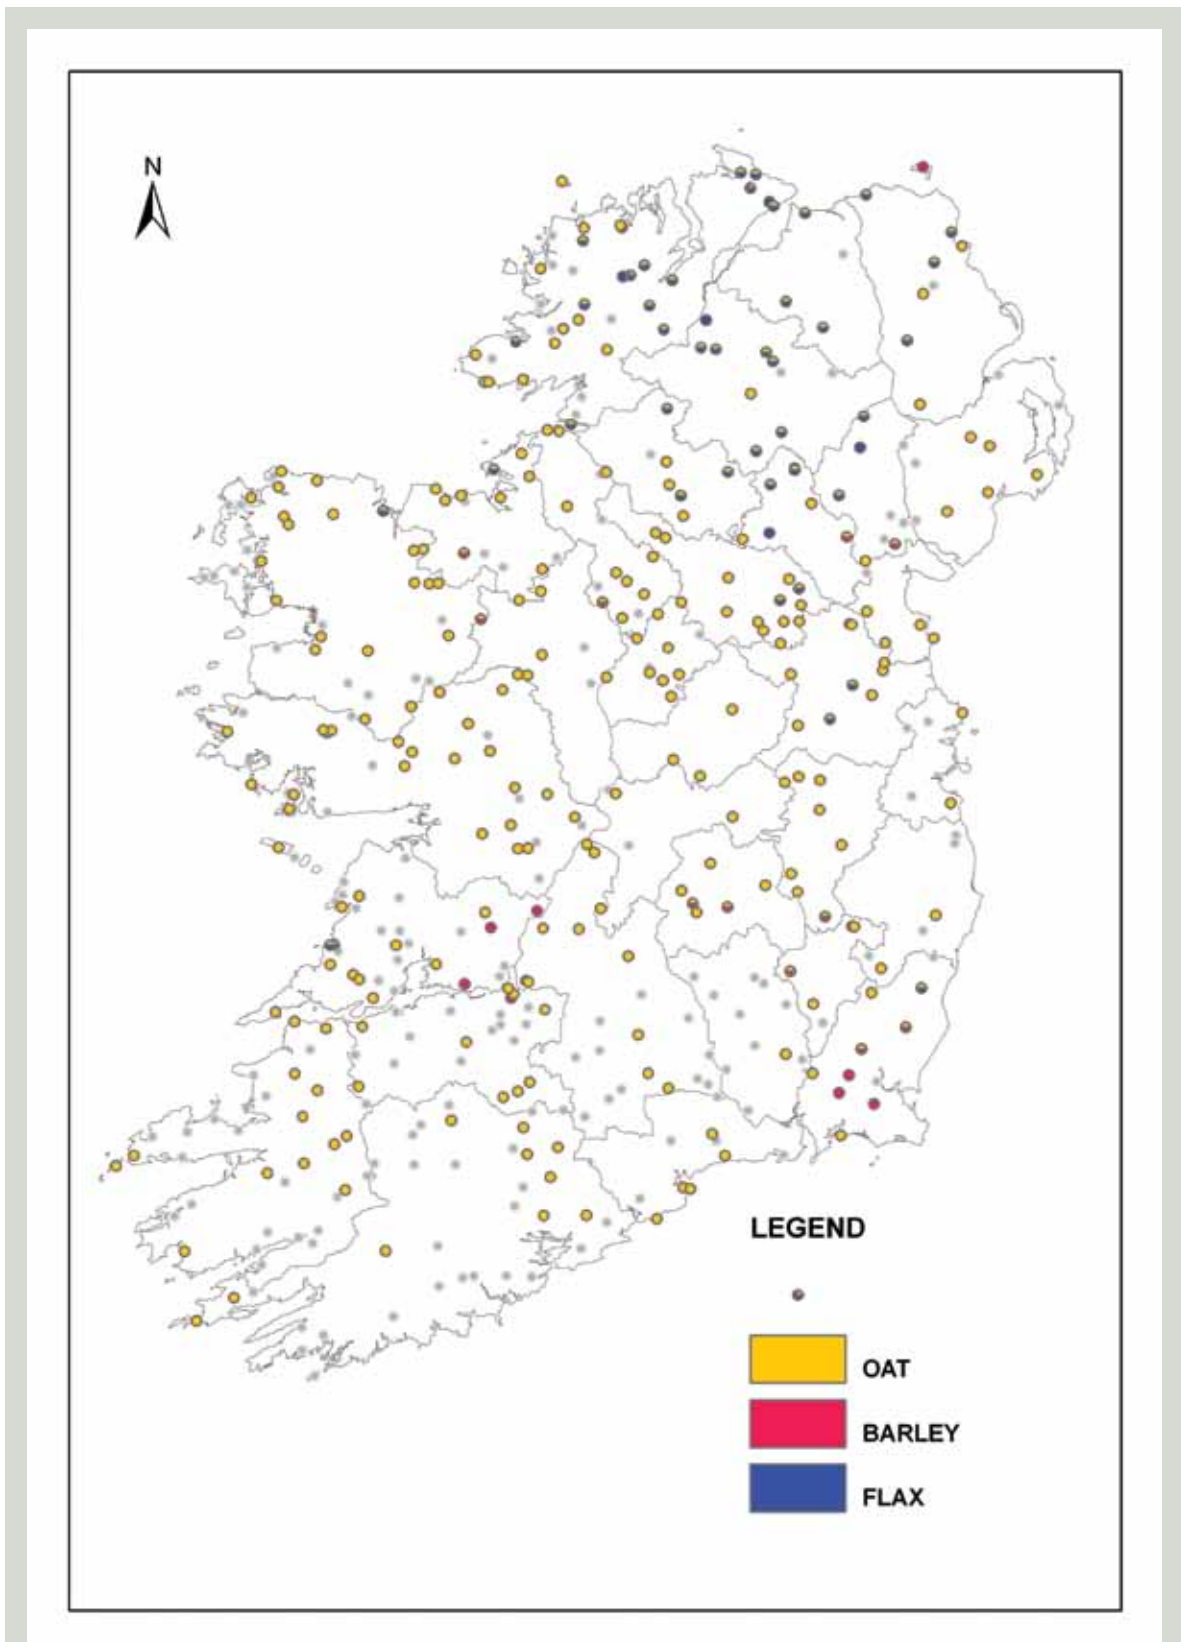
While oat was second in popularity to wheat, it had a wider distribution, noticeably in western counties, and less frequently elsewhere. Barley straw thatch was comparatively rare in 1945, while flax was strongly represented in northern counties, traditionally associated with the linen industry

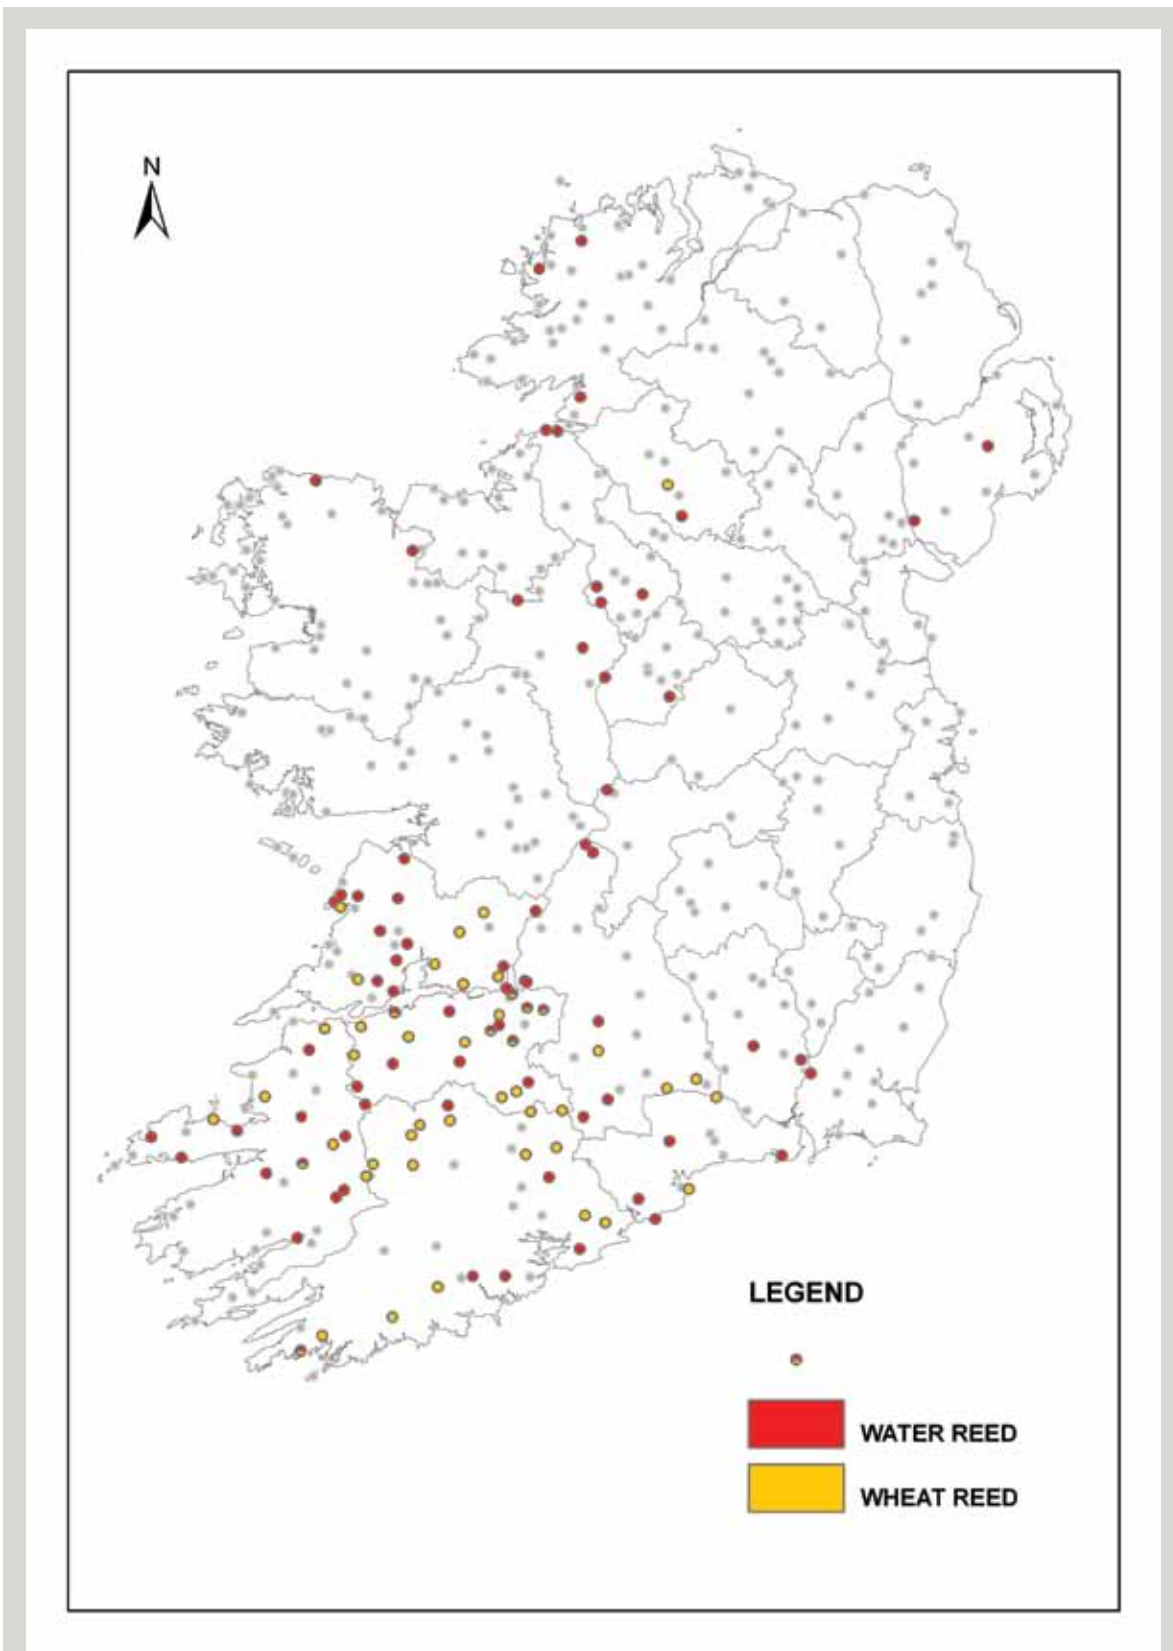
In 1945, water reed was best represented in Munster, where it was harvested on river banks, rivers and estuaries. Interestingly, wheat straw (sometimes referred to as 'wheat reed'), which is applied in the same 'butts down' fashion as water reed had a very similar distribution

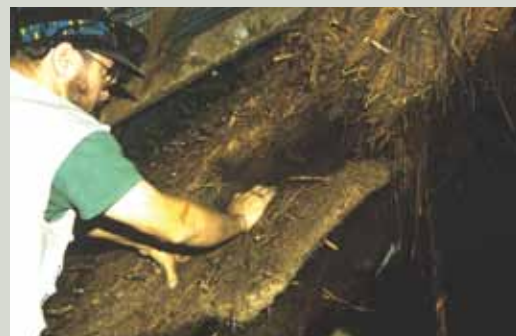
An archaeo-botanist examining historic thatch preserved under a corrugated metal roof

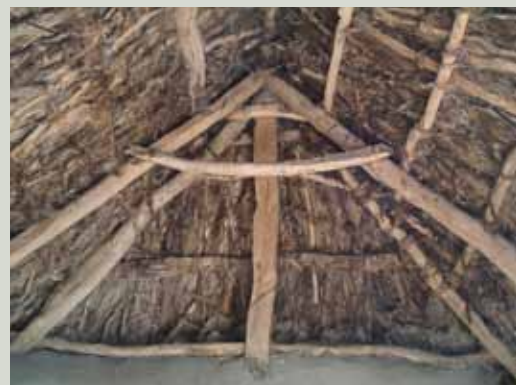
A vernacular roof structure in County Kilkenny having widely spaced, unwrought timbers with a pegged collar piece

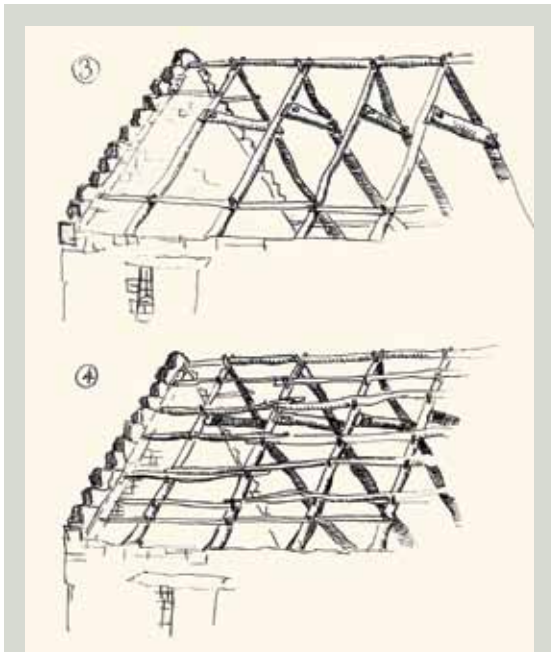
Drawings of the typical roof construction of a vernacular house in County Galway, by the artist Simon Coleman, 1959 (Image from the National Folklore Collection, University College Dublin)

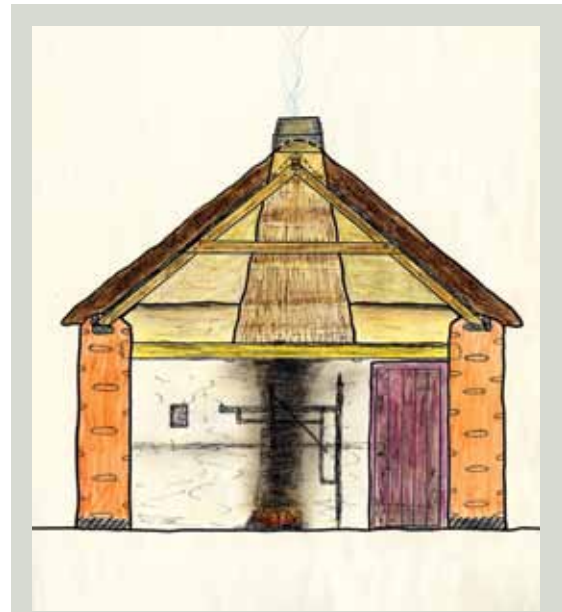
Thatched vernacular dwellings, such as this example surveyed by Caoimhín Ó Danachair in 1939 at Gortnagross, County Limerick, typically have a steep roof pitch (Image from the National Folklore Collection, University College Dublin)

Many factors affect the lifespan of thatch, especially the degree of exposure to wind and rain. Roof pitch (the angle the slope of the roof makes with the horizontal) is a key factor in this regard. The steeper the pitch of a roof the quicker it sheds water and, by doing so, increases the longevity of the thatch. Therefore the pitch of a thatched roof is usually 45° or greater which is considerably steeper than that used for tiled or slated roofs.

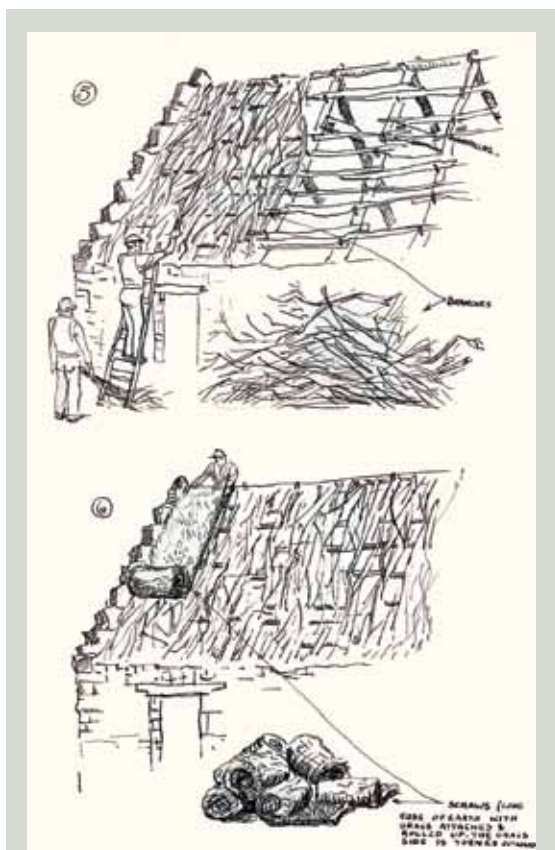
Rolls of cut scraw, or sods, laid on the roof's timberwork over a bedding layer of branches, County Galway. Simon Coleman, 1959 (Image from the National Folklore Collection, University College Dublin)

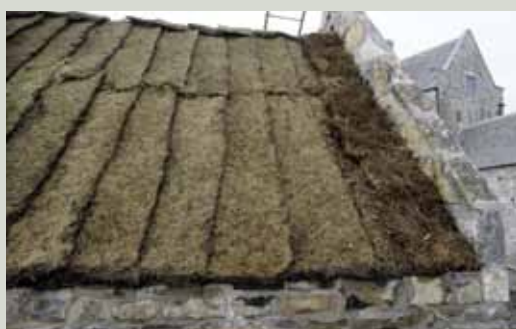
Scraw laid on a reconstructed roof

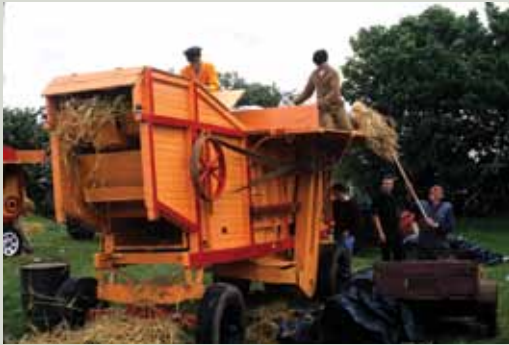
A threshing mill at work, Riverstown, County Sligo in 1993 (Image courtesy of Joe McGowan)

Wheat straw: This was formerly a by-product of bread wheats which were generally taller and hardier than cereals grown today and included varieties such as Squarehead wheat, or Rivet wheat which was more suited to biscuit and pastry making. However, higher yielding, short-stemmed cereal varieties, unsuited to use in thatching, have been preferred since the Second World War. To compound matters, the combine harvesters now used to harvest cereals generally crush the straw beyond use, effectively breaking the link between cereal production and thatching. The threshing mill, developed in the nineteenth century was less damaging, capable of producing straw which, though partially crushed, was still of acceptable length and sufficiently unbruised for use by thatchers.

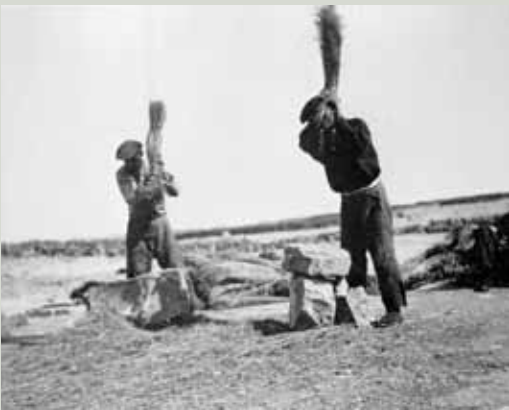
The traditional method of flailing or scutching straw, Aran Islands, County Galway (Image from the National Folklore Collection, University College Dublin)

Formerly, flailing or beating the ears to extract the grain was an even less damaging process, limiting the bruising to the tapered head of the stem. In many parts of Ireland, straw was threshed more judiciously still by grasping handfuls of straw and lashing the heads on a barrel or a stone to prevent breaking the stem. Thatching straw produced in this manner was sometimes termed 'reed' – a term which also covered oat, rye or even barley straw, but was more generally used for wheat.

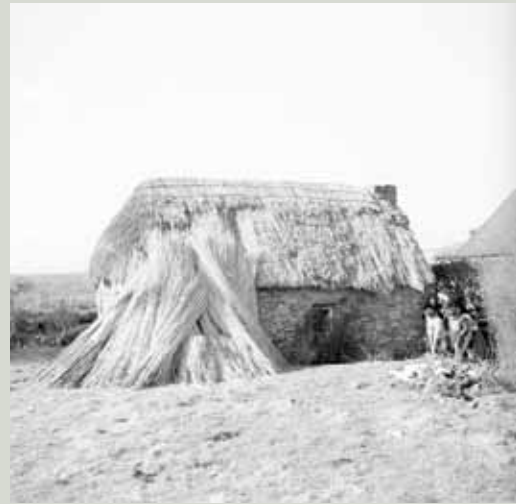
*Water reed thatch, harvested from the river Suir, County Kilkenny. Caoimhín Ó Danachair, 1963
(Image from the National Folklore Collection, University College Dublin)*

Munster has a strong tradition of indigenous water reed thatch, and, at the time of writing, it is the dominant roof covering in that part of the country. It is harvested between November and March along the river Shannon (in particular its estuary), the Suir, the Blackwater, the Slaney and other major rivers of Munster and also in south Leinster, where it is frequently known as 'spire'. As thatchers and owners look to source material locally and more cheaply, smaller reed beds, which may have been previously overlooked, are now being harvested. There was some concern that excessive nitrate run-off, until recently, had the effect of reducing the lifespan of water reed. However, recent significant improvements in water quality should mean that reed quality will also improve.

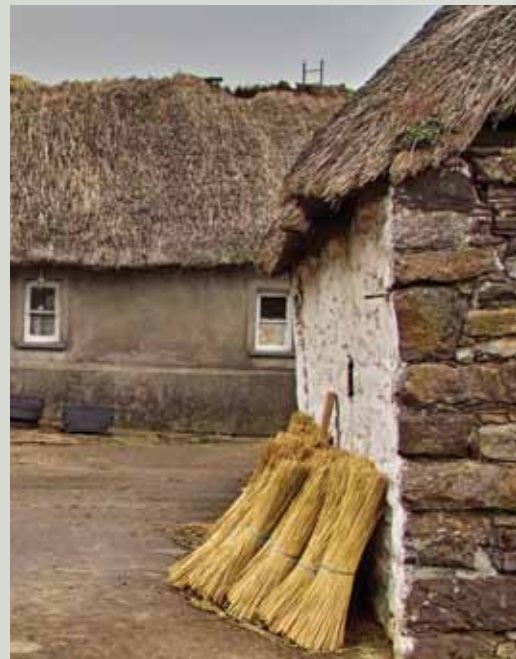
Bundles of water reed in readiness for thatching work, also in County Kilkenny

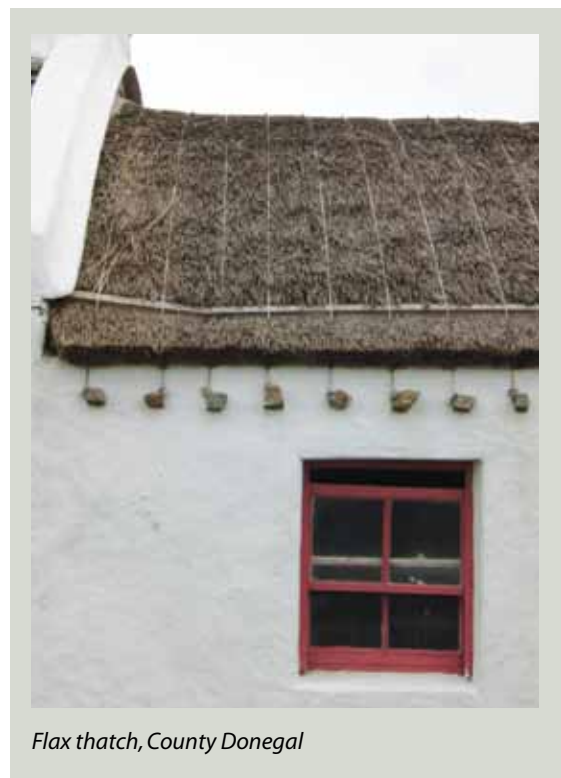
Flax thatch, County Donegal

Historically, the use of flax was closely associated with the linen industry in the north of Ireland, and is still occasionally grown in places as a specialised crop for thatch. Flax crops when of inferior quality, or when linen prices fell, were widely used as thatch. It is considerably coarser than straw and therefore harder to work.

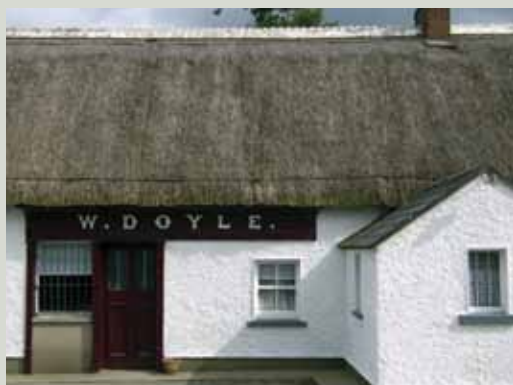
Thatched roofs in parts of Leinster were sometimes finished with decorative external ridge boards such as this example from County Wexford

The term 'ridge' refers to the apex of a double-pitched roof and also to the capping that covers it. The various ridge treatments do not merely provide decorative features to a thatched roof, they also have a practical function in reinforcing the ridge and helping to dispose of rainwater quickly from the most exposed part of the roof. Generally, ridge decoration on Irish vernacular roofs is restrained and plain. However, thatchers sometimes use the ridge or eaves as an opportunity to display their trademark or signature, so that all the roofs of a particular thatcher in a certain region or district have a distinctive look.

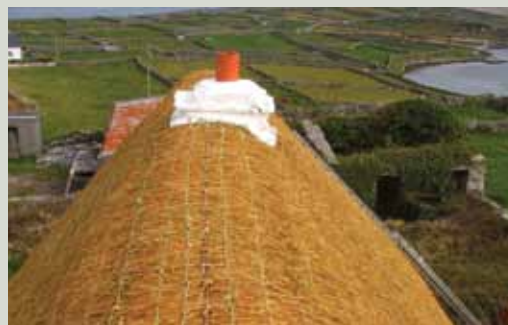
Roped thatch with flush (rounded) ridge

Flush or plain ridge: With a straw roof, an evened out layer of straw is bent or wrapped over the ridge rolls and secured on each side of the ridge with stretchers. This wrap-over layer should be a minimum of 100mm (4in) thick at the apex. For reed roofs, the ends of the top layer are butted together along the apex of the roof on both sides to form a slightly raised but flush ridge and pinned with a line of stretchers.

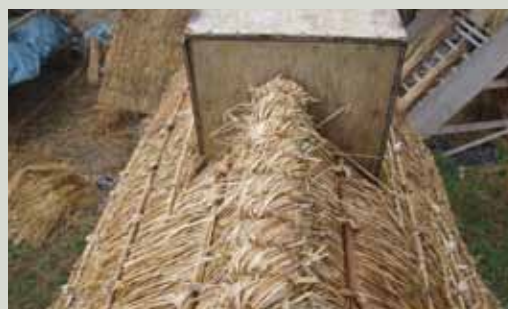
*Straw flush ridge with bobbins and rodding
(Image courtesy of Brian Simpson)*

Twisted or bobbin ridge: This type of ridge is formed of a series of straw bobbins strung together on a scollop stretcher, and applied to one or both sides of the ridge. To make a bobbin, a handful of clean, long straw is twisted at its centre and folded in two, and a loop or eye is created in the fold by tightly twisting several wisps of the straw around the folded bundle close to the top. About fifteen bobbins are strung on a single stretcher, equal to the width of the strake, leaving several inches of rod free at either end to drive into the adjacent row of bobbins. This is secured to the ridge with scollop pins. Where bobbins are applied to both sides of a ridge, the line of bobbins on the weather side of the roof is normally set above the line of bobbins on the sheltered slope to prevent rain entering the apex of the ridge. In this way too, a single scollop pin can secure both lines of bobbins to the apex of the ridge at the same time.

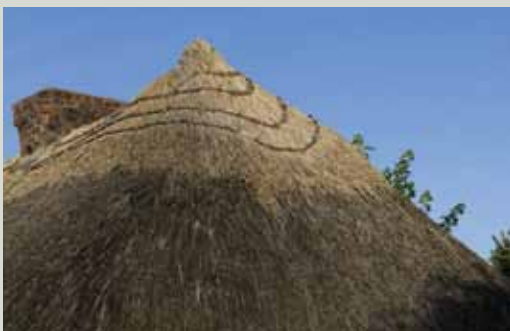
Rows of horizontal stretchers can provide a decorative detail in addition to their functional role of securing the ridge and other vulnerable parts of the roof, County Limerick

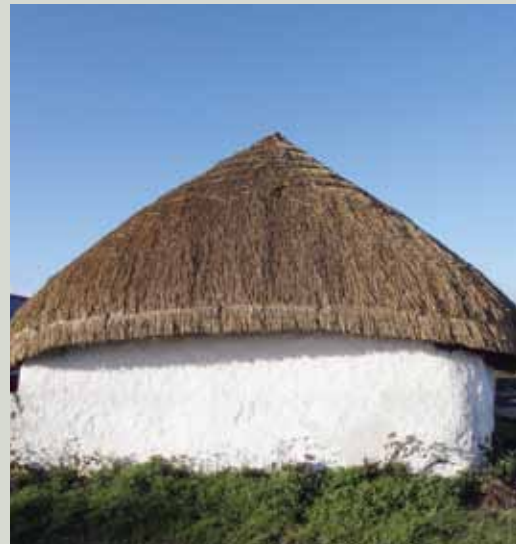
A hipped roof of oat straw thatch on an earth walled house in County Offaly

East of the Shannon, where many thatched buildings are mud-walled, roofs were usually hipped so that the thatch could provide protection to the tops of the end walls. West of the Shannon, where the walls tend to be of masonry rubble construction, the buildings were more generally gable-ended with the thatch continued partly over the gable wall. The gable walls usually have a narrow stone upstand or coping which protects the ends of the thatch from wind uplift. In some areas (for example, County Mayo and on the Aran Islands) these upstands are stepped so that the horizontal ropes of a roped thatch roof can be passed across the steps and tied to fixings in the walls below.

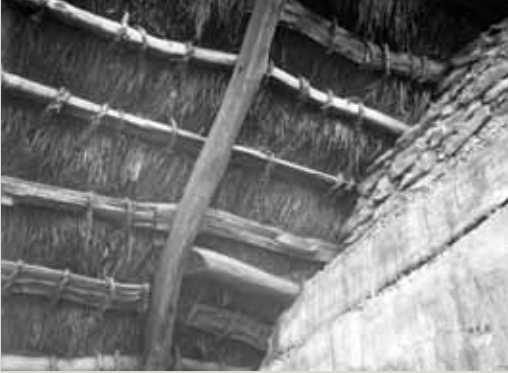
Súgán tying the base coat of thatch to the roof timbers in County Limerick. Caoimhín Ó Danachair, 1963 (Image from the National Folklore Collection, University College Dublin)

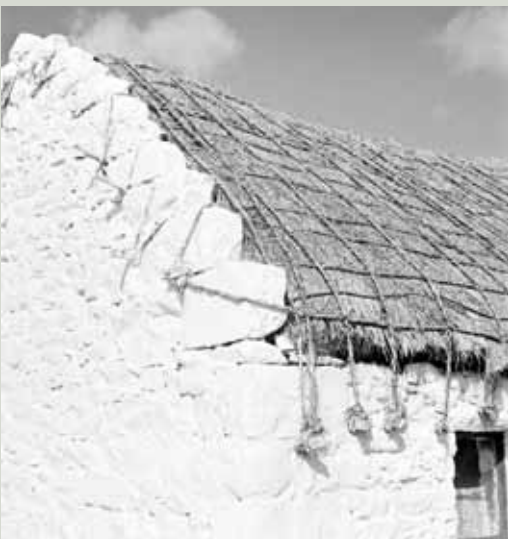
Detail of gable tyings in a roped thatch, County Mayo. Caoimhín Ó Danachair (Image from the National Folklore Collection, University College Dublin)

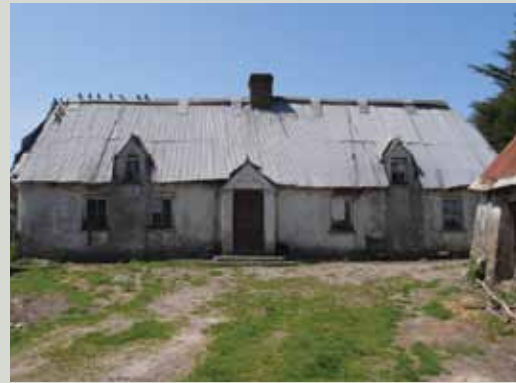
Many examples of historic thatch are still preserved under metal coverings. Colloquially referred to as 'corrugated iron', the material used, since the 1880s, has in fact been mild steel

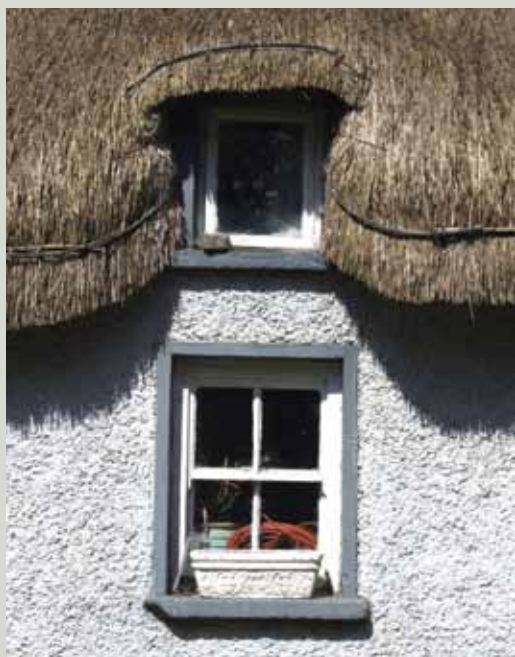
A half-dormer window within a straw thatched roof, County Wexford

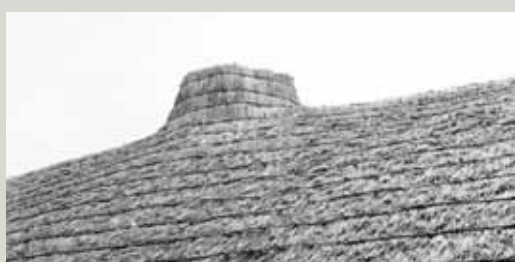
Thatched chimney, County Clare. Caoimhín Ó Danachair (Image from the National Folklore Collection, University College Dublin)

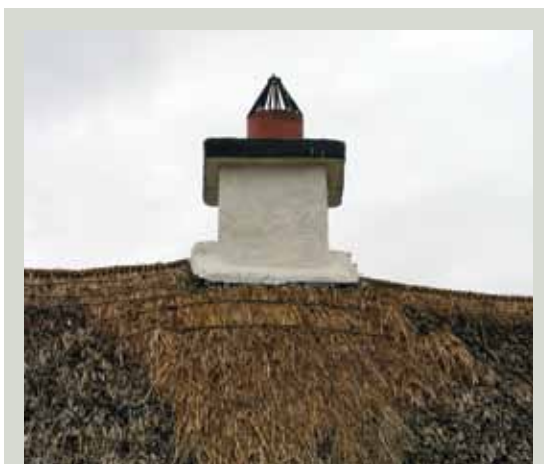
Typical rendered masonry chimney with mortar flaunching at the base and firmly scoloped thatch around it

The natural vulnerability of thatch to fire meant that it was essential to ensure that sparks were prevented from coming into contact with the thatch material. Very large chimneybreasts ensured that sparks rose slowly from the fire and were extinguished before reaching the top of the chimney.

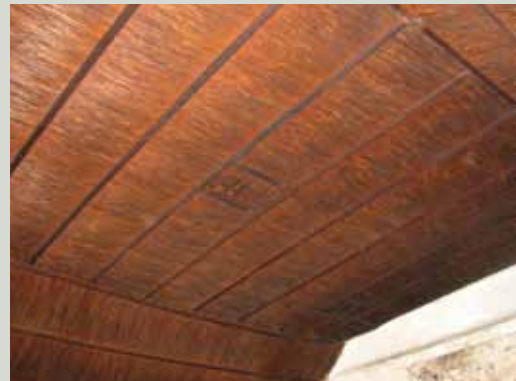
Ceiling made from reed fleeking

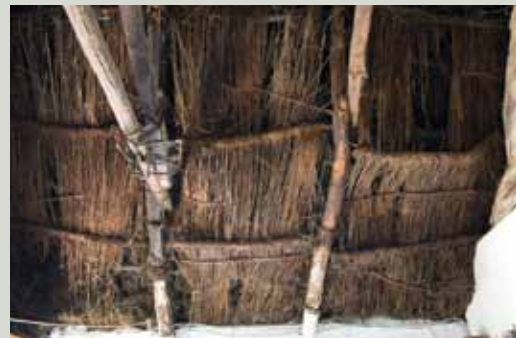
Straw lining to the underside of a roof in County Limerick

A fleeking, or woven mat of water reed, straw or sedge, is sometimes found in association with straw base coats, having a dual function of sealing the thatch from the inside (restricting the ingress of dust and insects) and providing an aesthetic appeal. A similar role was played by a layer of vertically hung straw beneath the thatch, held in place by horizontal scollops or small branches. Another type of ceiling known as a ribbery is occasionally found formed by the careful placing of a layer of hazel rods fixed directly to the underside of the roof structures. In other examples, the roof trusses are wrapped in carefully placed straw-work. All of these ceiling types are now quite rare and should be protected.

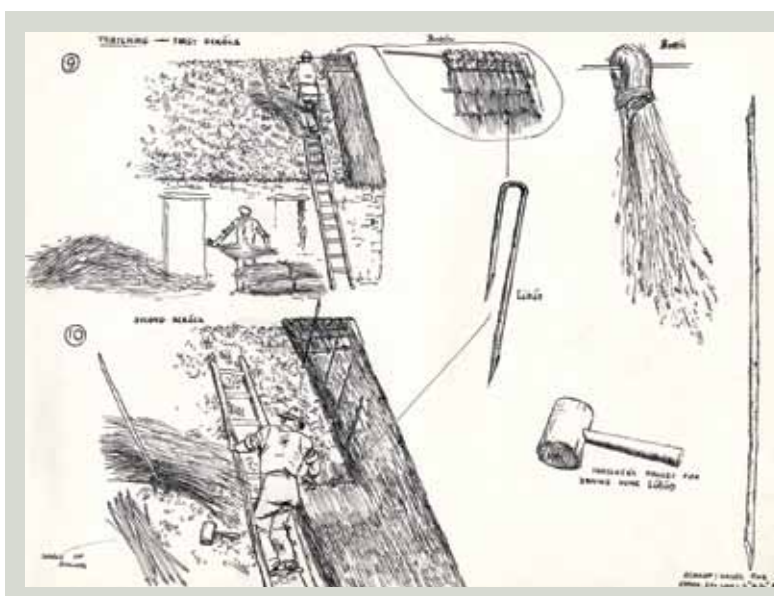
When thatching with scollops, the right-handed thatcher generally works from right to left in bays or strakes, finishing each strake at the ridge with a row of bobbins and lines of rods. Simon Coleman, 1959 (Image from the National Folklore Collection, University College Dublin)

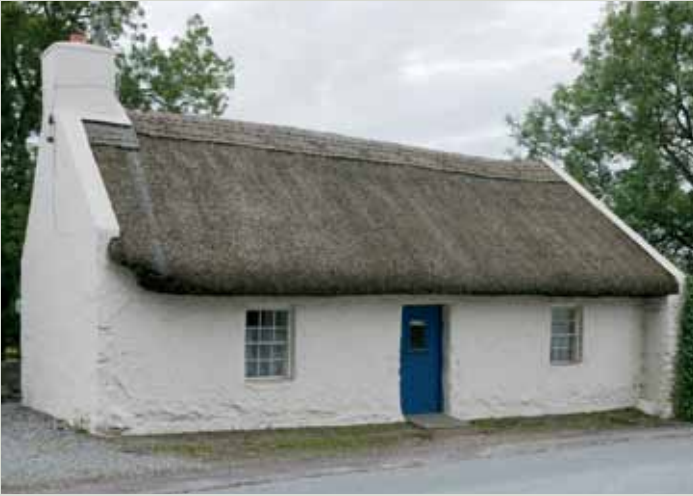
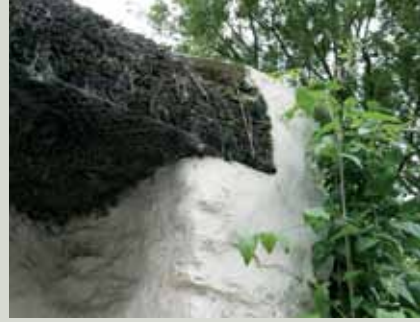
A roof in County Cork with raised gable copings to protect the edge of the thatch from wind uplift. These gable copings also cover the edge of the thatch as can be seen at the eaves detail

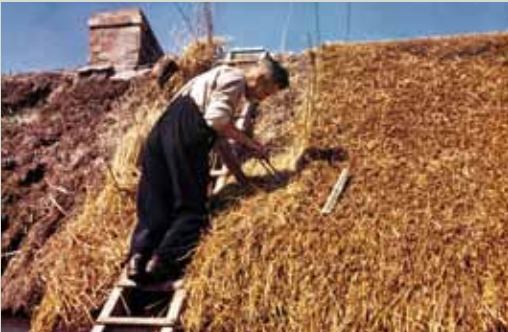
Thatcher driving home a hairpin scollop. Caoimhín Ó Danachair (Image from the National Folklore Collection, University College Dublin)

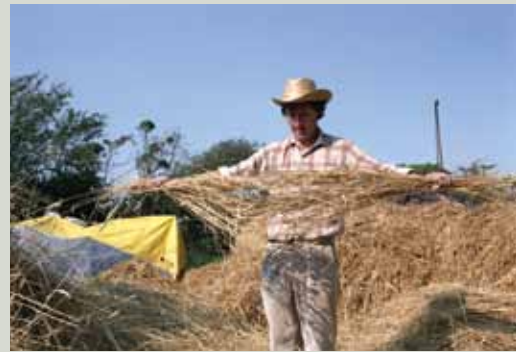
A thatcher drawing straw

Before it can be applied to the roof, straw should be thoroughly wetted on the ground to make it pliable. Handfuls of loose straw, of which the butts and ears are jumbled, are drawn or teased out with both hands to remove waste and arrange the stems in straight, compact bundles. These are handed up to the thatcher who works in narrow strakes, occasionally in wider sections, from eaves to ridge, and normally, from right to left.

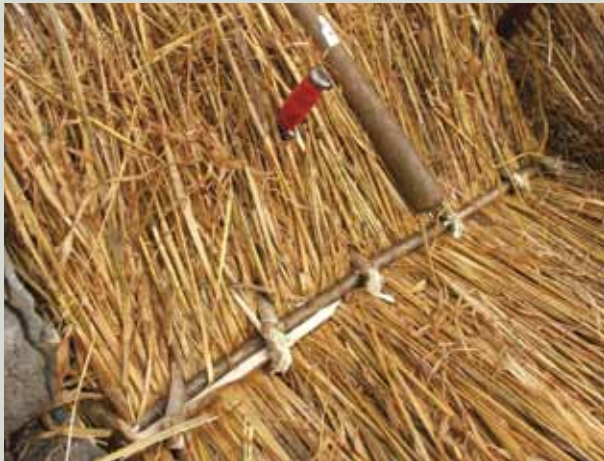
A course of thatch is fixed firmly in position with a scollop keeper and several hairpin scollops

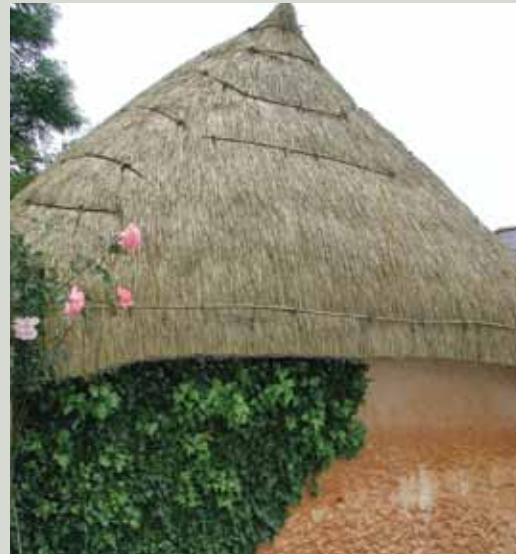
An oat straw thatch in County Kildare with external fixings at the hips and eaves providing extra strength to the more vulnerable parts of the roof

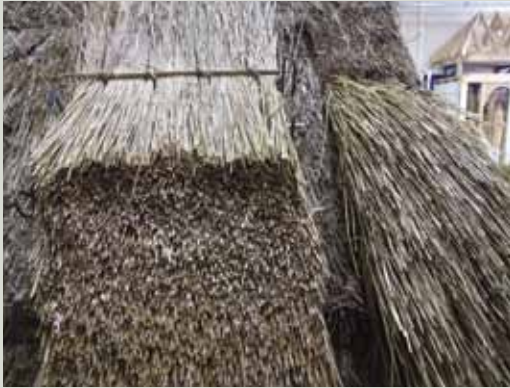
An exhibition of contrasting methods of thatching – showing scolloped rye thatch to the left and thrust wheat straw thatch on the right (Image courtesy of Brian Simpson)

Today, thrust thatch is associated with north and east Leinster but it has been used elsewhere, for example in south-east Ulster and east Galway. It is also known as sliced, spliced or fletched thatch. Oat straw, which is more flexible than wheat, is preferred, though the latter is also used. Thrust thatch lasts well depending on workmanship and material, although most thatchers agree that it has a shorter lifespan than scolloped thatch. The straw should first be prepared by wetting it and handfuls of straw pulled or teased from a bed of straw to make bundles. The wetting makes it easier to manipulate and bend the straw as the method relies on the thatcher being able to knot the bundles for thrusting, knot first, into the base layer.

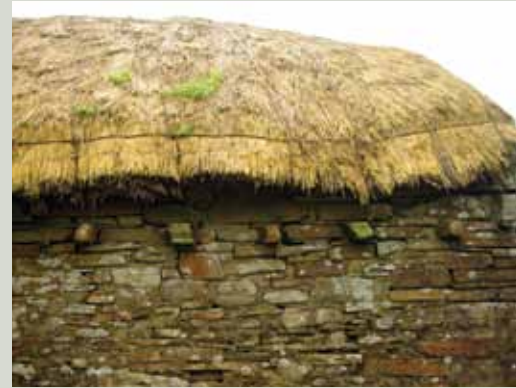
An example of roped thatch in County Donegal. Ropes passed over the roof at regular intervals secure the thatch against high winds and are tied to stones projecting from the walls

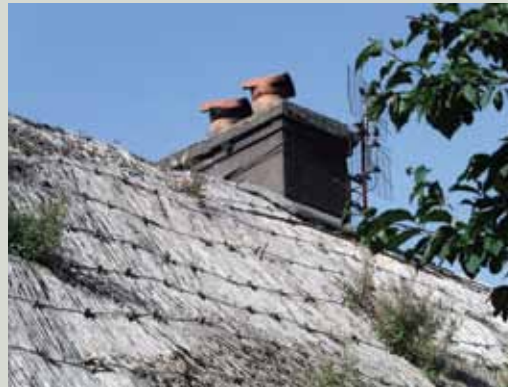
Now in poor condition, this example of a straw, pegged thatched roof in County Sligo is an increasingly rare survival

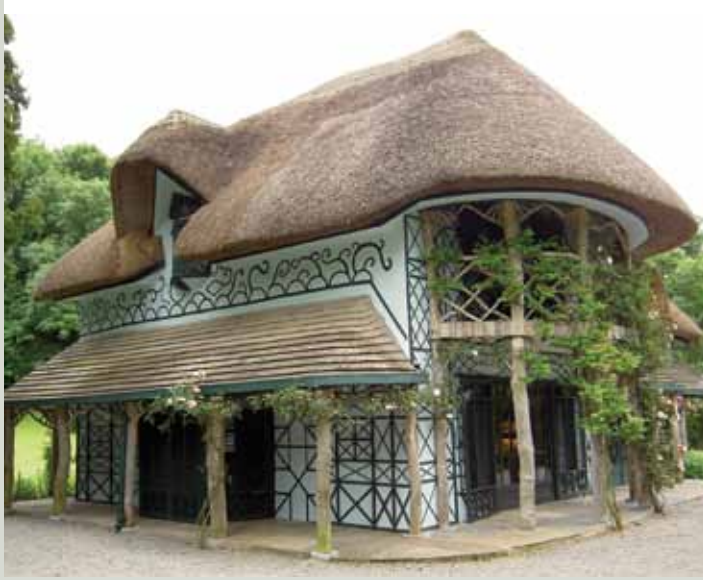
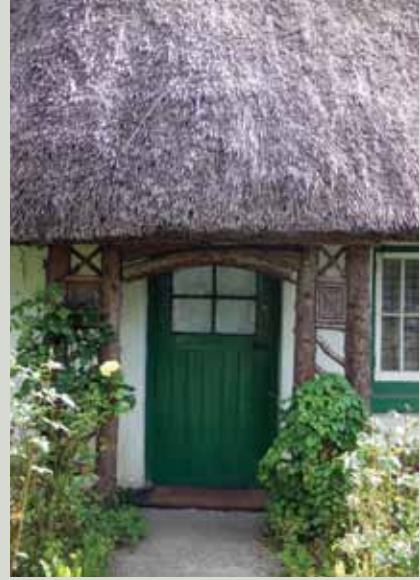
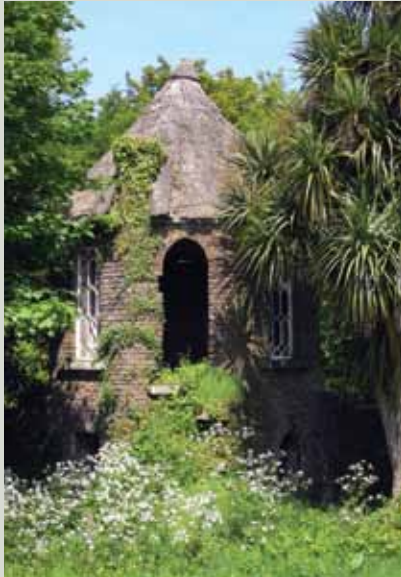
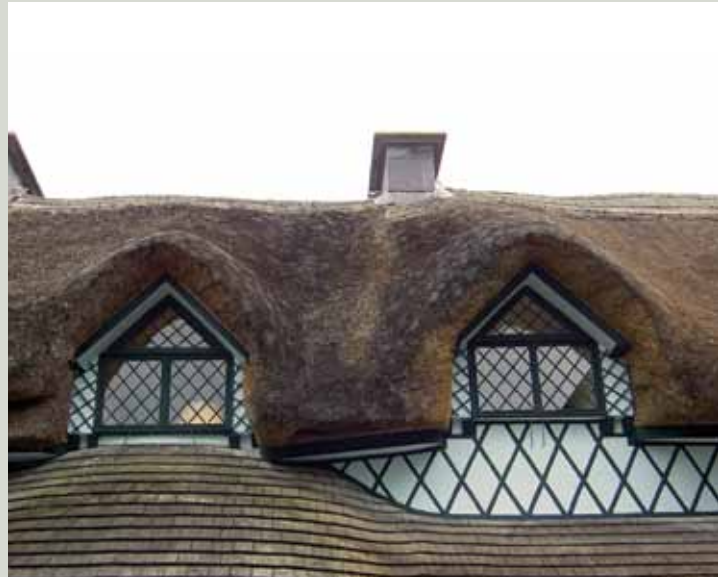
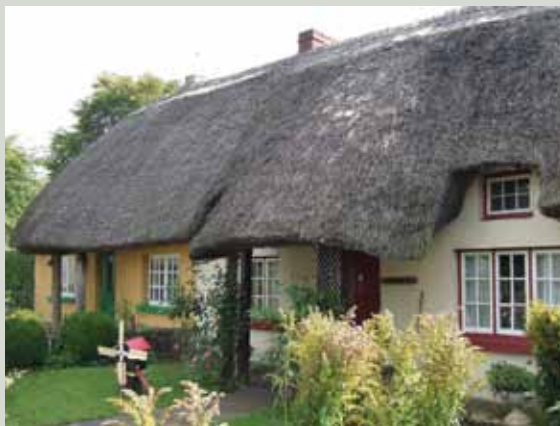
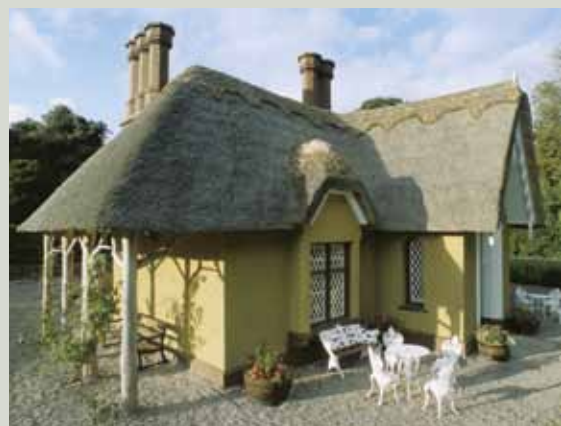
Examples of thatching in the cottage-orné tradition including the Swiss Cottage, County Tipperary; Adare village, County Limerick; Rockspring, County Wexford and Killarney, County Kerry

Cottage orné is the term applied to a picturesque cottage built in a romantic rustic manner, usually located within the demesne of a large country house. Gate lodges, follies, summer houses and bowers were also designed in this way. Several of these survive and they can be very beautiful and worthy of protection in their own right. However, they should not be confused with the vernacular thatch tradition; nor should the materials and detailing appropriate to a cottage-orné be used when re-thatching historic vernacular buildings and vice versa.

One of the most striking examples of a cottage orné in Ireland is the Swiss Cottage built by Richard Butler, later the earl of Glengall, on his demesne at Cahir House, County Tipperary. Designed by John Nash, it was constructed in the second decade of the nineteenth century. Having fallen into decay, it was restored in the 1980s by the Office of Public Works.

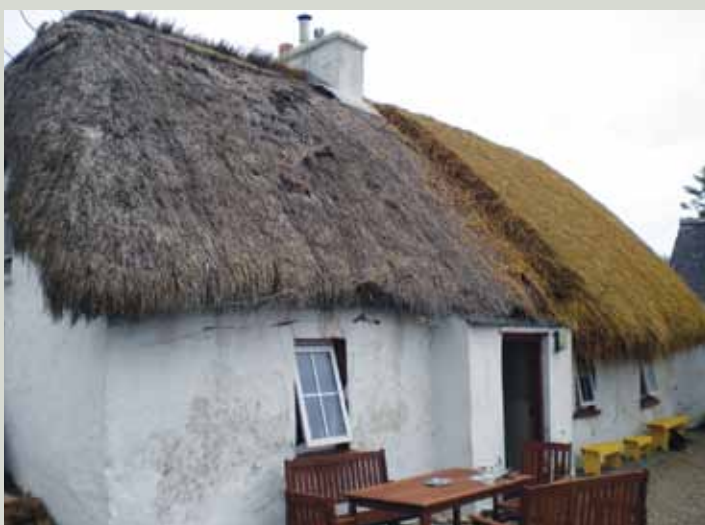
A major re-thatching emphasises the degree to which weathering and decay in time reduce the thickness of thatch

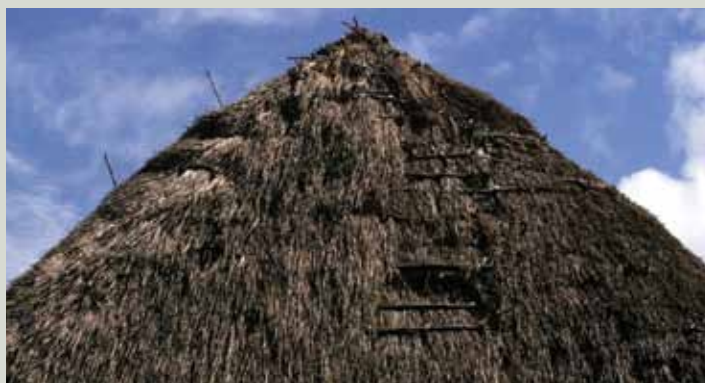
Fixings becoming exposed on the thatch surface indicate that the roof needs re-thatching

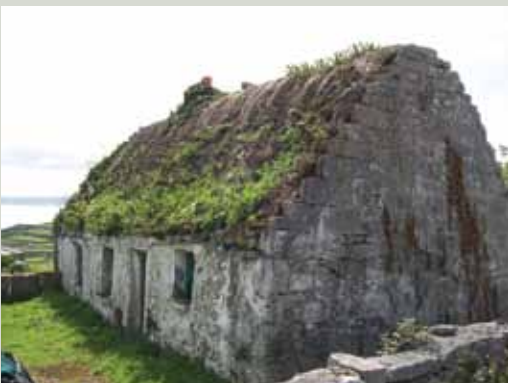
The results of lack of maintenance. Due to the fragile organic nature of the materials used in thatch, buildings can deteriorate rapidly when neglected

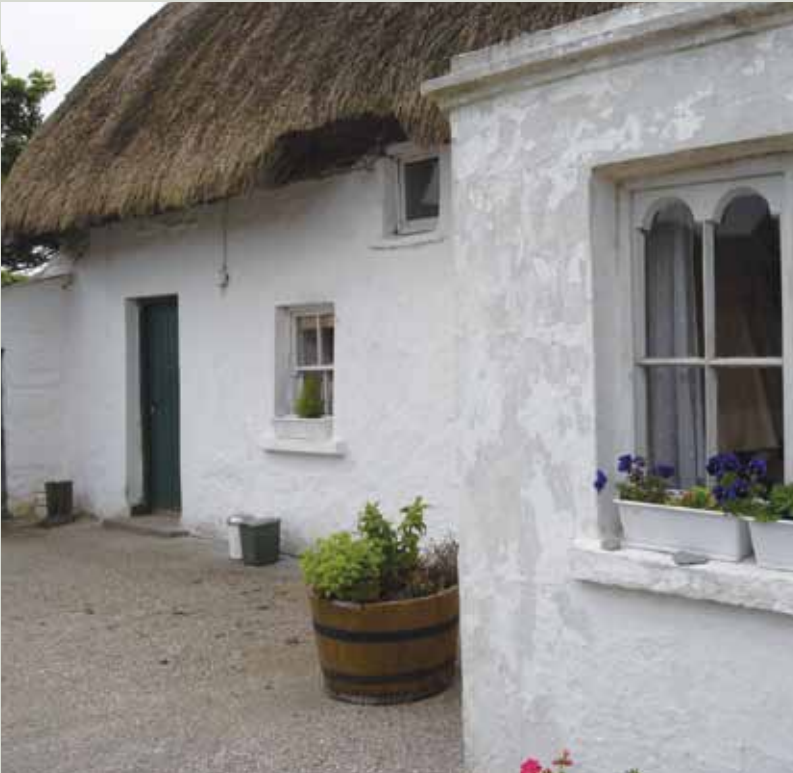
As thatched roofs do not have gutters to collect rainwater coming off the roof, a deeply overhanging eaves is essential to throw water well away from the walls to avoid saturation

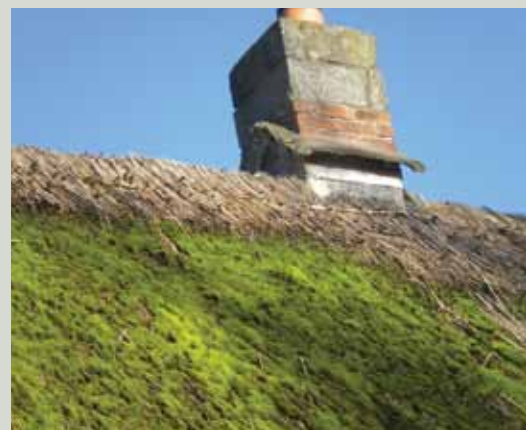
Severe moss growth on a roof will encourage the saturation of the thatch below leading to its decay

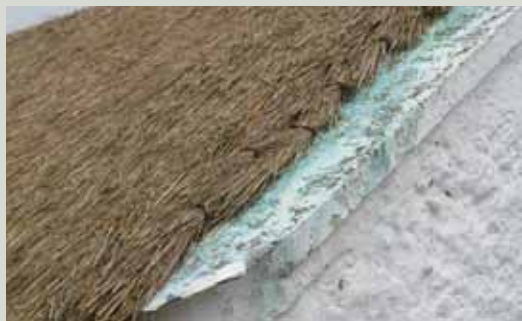
The typical blue run-off of copper sulphate solution can be seen on the verge of this roof indicating that a treatment of bluestone has been applied to the thatch

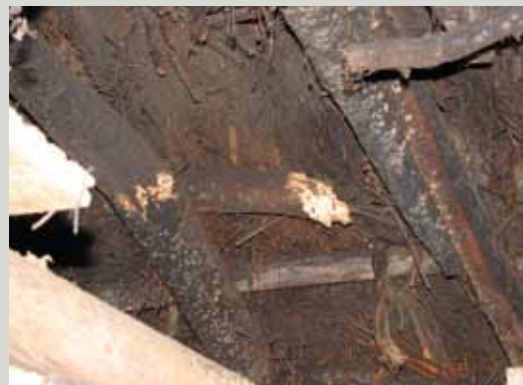
Broken roof timbers in a thatched house with evidence of furniture beetle infestation

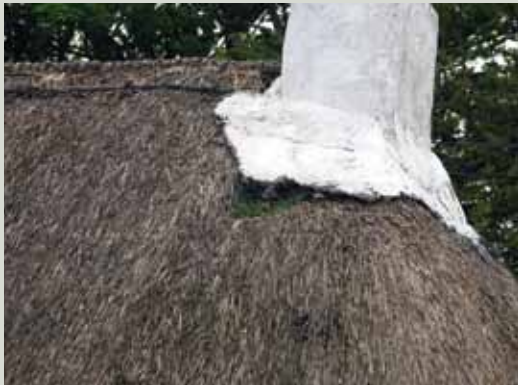
The shrinkage of thatch in vulnerable areas of the roof such as at the base of chimneys facilitates water ingress and should be repaired quickly

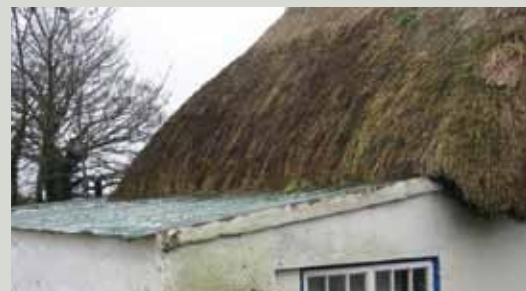
The end of the thatch sits on the lean-to metal roof of an extension. Rainwater shed from the thatch cannot drain properly and will eventually lead to rotting of the thatch
