A GUIDE TO THE REPAIR OF THATCHED ROOFS

An Roinn
Ealaíon, Oidhreachta agus Gaeltachta
Department of
Arts, Heritage and the Gaeltacht

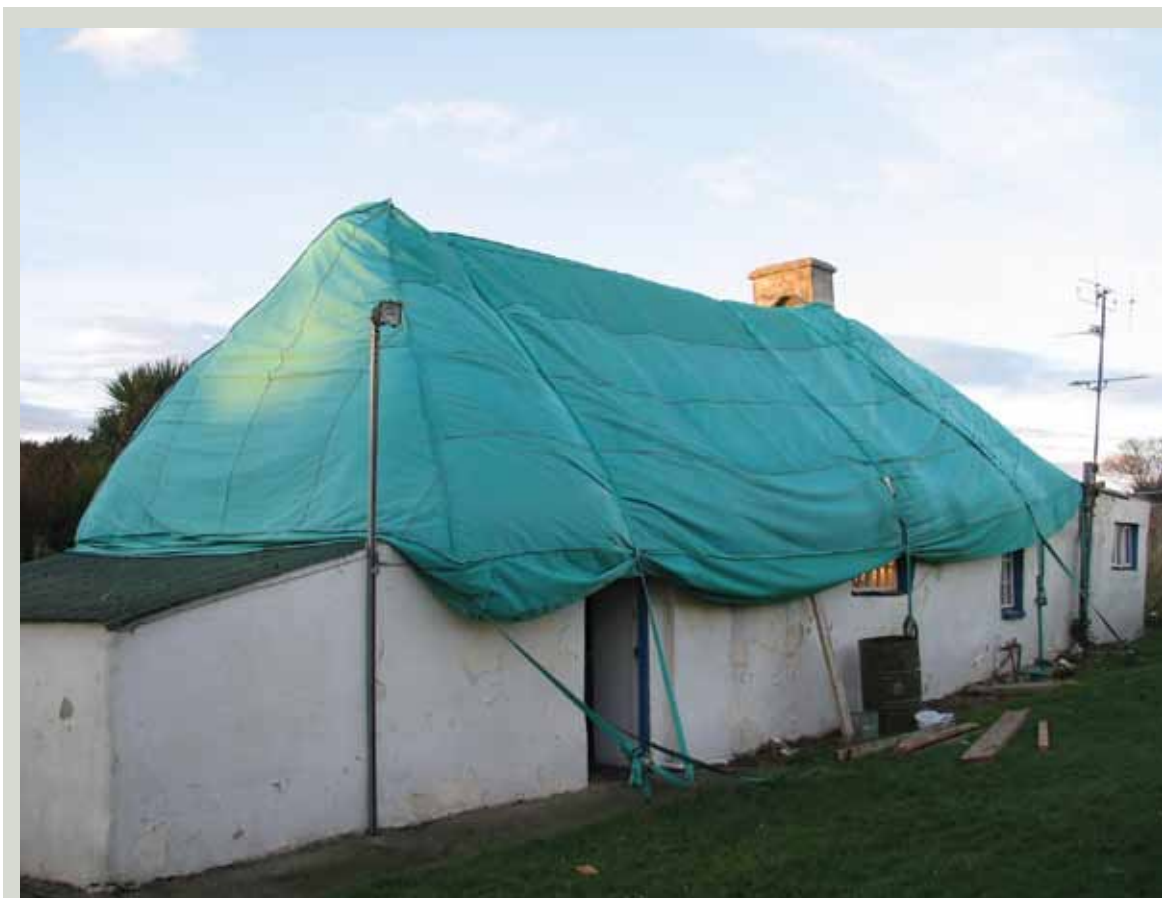
Temporary protection provided by canvas sheeting may provide a short-term solution in an emergency but can accelerate the deterioration of the thatch by preventing it from drying out

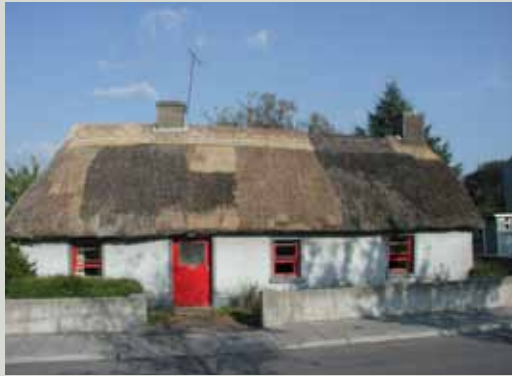
Regular patching and repair have always been features of maintaining a thatched building, a process which extends the life of a roof until such time as a full re-thatch is necessary

A thatch which is regularly maintained and repaired should last longer and function well. A level and tight roof with a good thickness of thatch (say, 350mm or 14in) enables scollops to fix better into the old thatch when a fresh coat is being applied. The thickness of a thatch coat decreases as it weathers and a clear sign of the need for re-thatching a scolloped straw roof is, for example, when internal, formerly hidden, fixings become exposed. The thatcher responsible for the most recent re-thatch, who is familiar with the roof, or an otherwise experienced thatcher, should be consulted before deciding whether to patch or re-thatch. Individual roof slopes perform differently – south-west facing slopes, subject to more adverse weather conditions, may not last as long as other parts of the roof. Before undertaking a major re-thatch, it is wise to clearly identify the materials that make up the roof, both base and weather coats. The weather coat is easily accessible and, by drawing a few wisps of straw from an exposed area in the roof void or from the innermost part of the thatch in the eaves outside, it should be possible to identify the material in the base coat. Bear in mind that the base coat (or substantial parts of it) may be quite old and contain more than one type of straw: in many parts of east Munster and Leinster, for instance, wheat straw gave way to oat straw thatch over the course of the twentieth century.

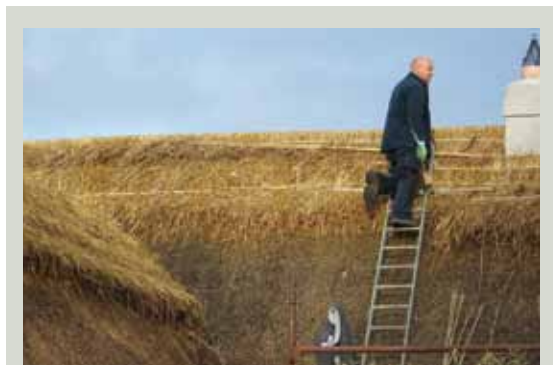
Renewing the ridge of a thatched house in County Meath (Image courtesy of Brian Simpson)

Certain parts of a thatched roof require renewal or repair on a regular basis. A thatch owner should expect to renew the external ridge and eave rod fixings every six to seven years or following damage such as in a storm, work which is best carried out by an experienced thatcher. At the same time, the surface of scolloped straw or water reed thatch should be raked to remove perished butts and the thatch dressed with a legget to tighten the roof. This can extend the life of the thatch for several years. In the event that holes or dips have formed in the roof, these should be cleaned out to a firm base and patched. Where a roof is thrust thatched, patching can be carried out with fresh bundles of straw secured in position by thrusting them into the existing thatch and building up the level of the depression to match the surrounding surface without using fixings of any kind. Where the roof is of scolloped thatch, patches can be scolloped in position using scollops as external fixings.

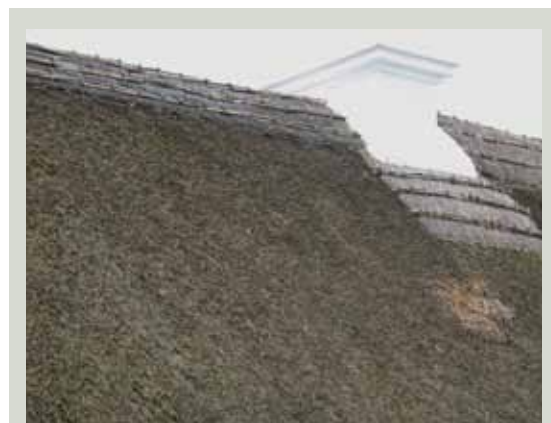
Renewal of vulnerable sections of a roof, particularly the ridge and base of the chimney can extend the lifespan of a thatch

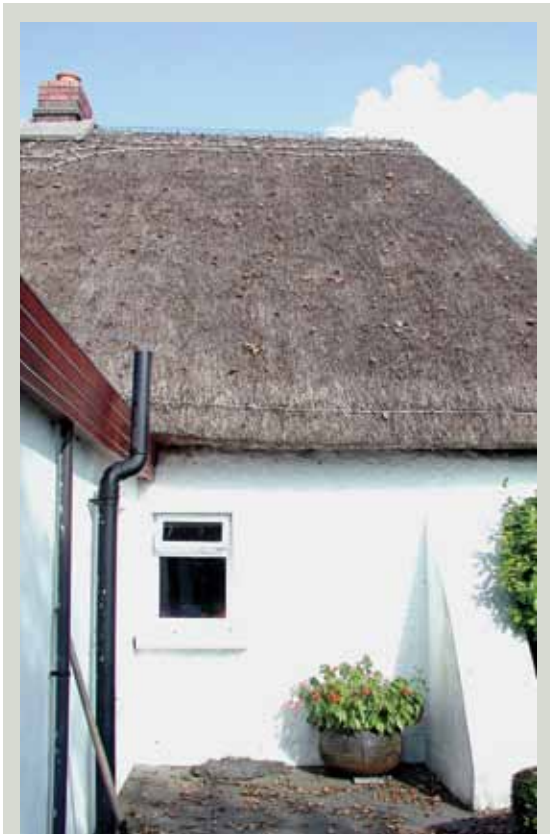
Wire netting can trap fallen leaves, delaying the run-off of rainwater and so accelerating the decay of the thatch

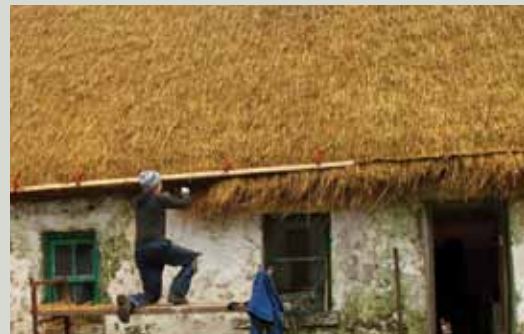
Trimming the eaves following a re-thatch

The thatcher should ensure that all scollops are well concealed below the weather surface of the thatch, typically 150-200mm (6-8in). The edge of each strake should be left loose so that the adjoining strake can be inserted under it. This ensures that the joint between the sections of thatch does not become a weak point in the roof surface. The thatcher should allow for the tapering effect of each course to ensure that the correct pitch and depth of material are maintained throughout as he progresses upwards towards the ridge. Often it is necessary to 'back-fill' the heads of bundles above their fixings to maintain correct pitch and to facilitate dressing. At the apex of the roof, about one-third the length of each bundle is bent over the ridge and three to four horizontal scollops applied to secure the bundle. The outermost lines of these scollops are necessarily left visible and may be supplemented by an extra line of rodding. The space between the lines of scollops is often worked into a decorative chevron or lozenge pattern of crossed rods. The main coat is then beaten down and raked smooth, and the eaves are trimmed with a sheep shears to tidy them and to trim the overhang.

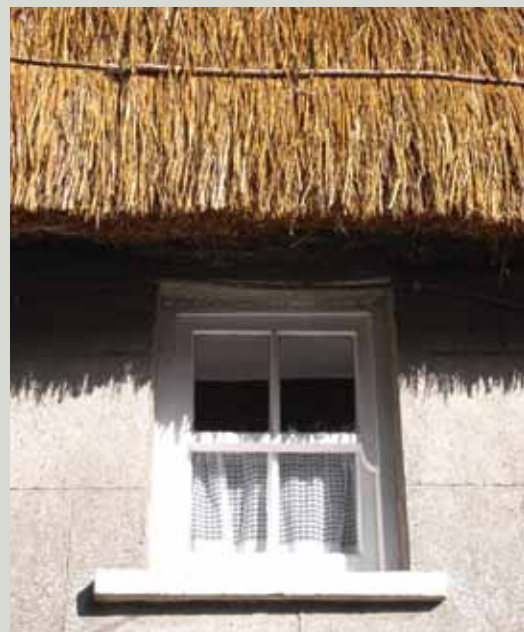
Straw thatch, in County Wexford, using horizontal stretchers to pin and tighten the eaves

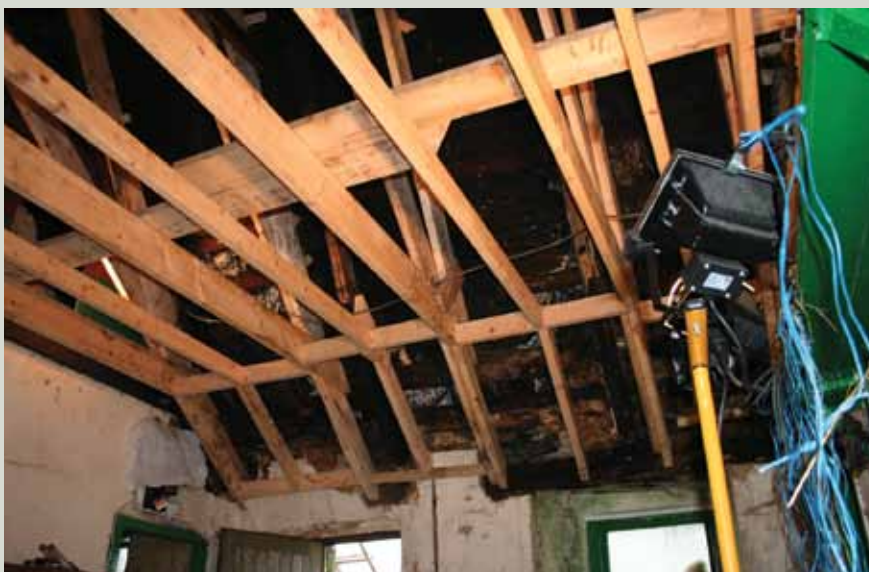
A new roof structure has been inserted beneath an old roof, strengthening and, at the same time reinforcing, the original structure which has been left in place above. However, a major intervention of this type is only justifiable where there has been a widespread failure of the existing structural elements

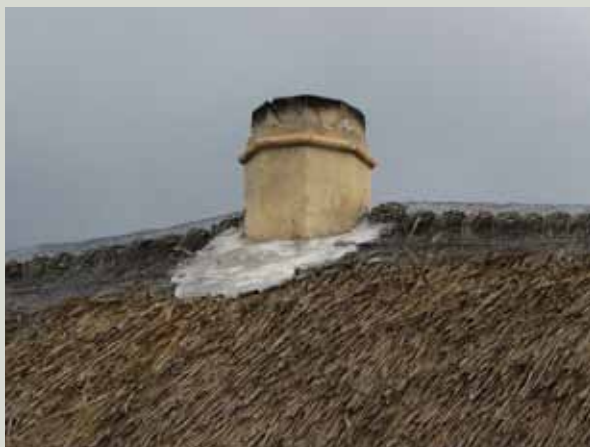
Low-rise chimneys are traditional on thatched buildings. They rely on large chimneybreasts below to ensure that sparks from the fire are extinguished before they reach the upper parts of the chimney

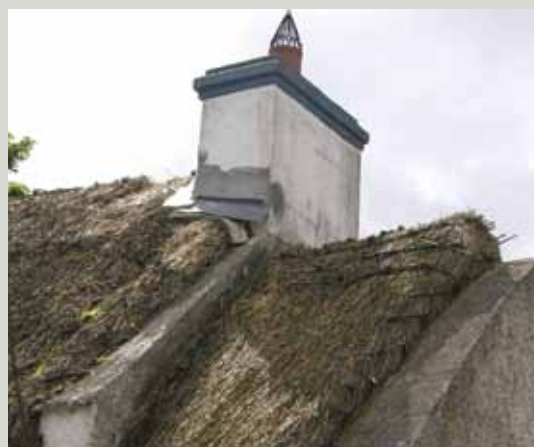
The poor quality flashing detail at the foot of this chimney stack is causing localised deterioration of the thatch

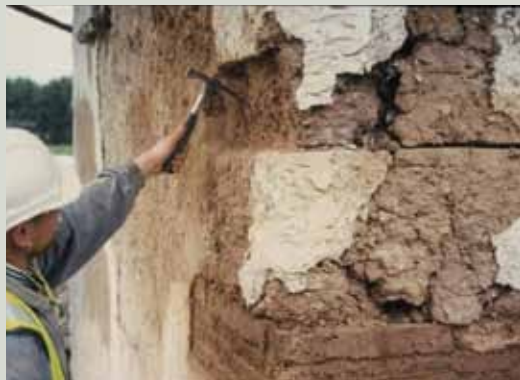
Repair of a corner crack in an earth wall

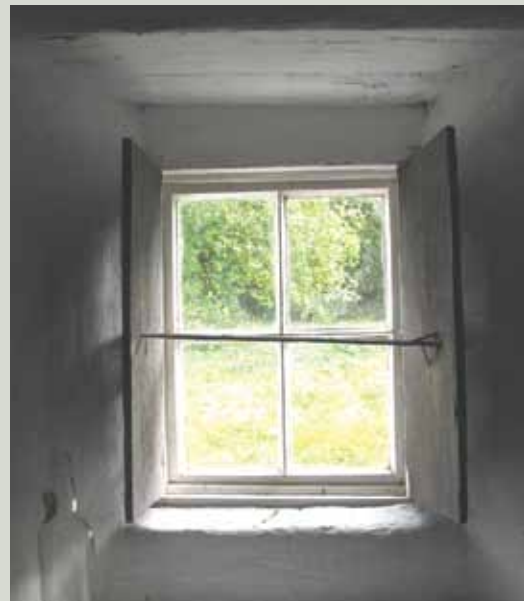
A small sash window with simple internal shutters is typical of vernacular houses

The condition of timber doors, window sashes and frames can be quite variable. The most vulnerable areas – the bottom rail of the door or sash and the sill of the frame are usually the worst affected. However, most of the timber elements can be readily repaired by a skilled craftworker using normal joinery methods. For more information see *Windows – a guide to the repair of historic windows* in this Advice Series.

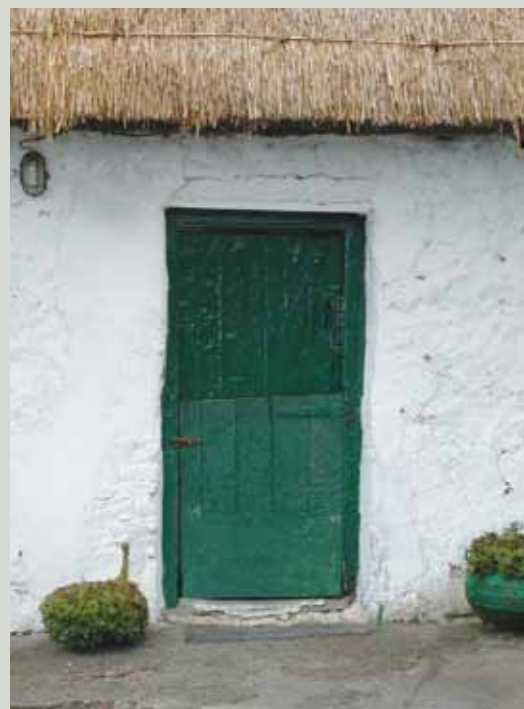
A traditional timber half door

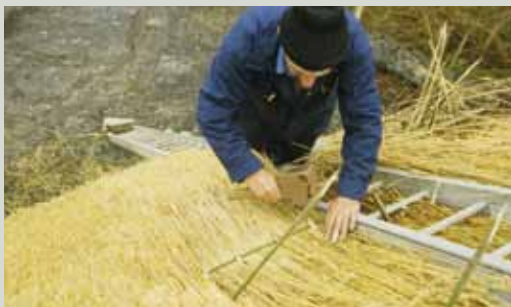
Re-thatching with rye straw, County Leitrim

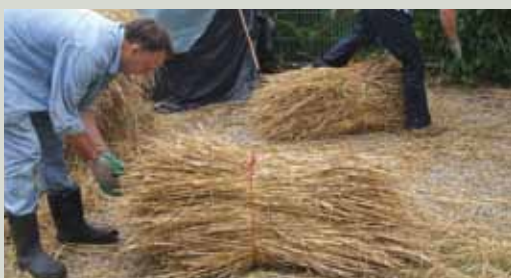
*Tidying the ends of drawn bundles of straw
(Image courtesy of Brian Simpson)*

Before it can be applied to the roof, straw should be thoroughly wetted on the ground to make it pliable. Handfuls of loose straw, of which the butts and ears are jumbled, are drawn or teased out with both hands to remove waste and arrange the stems in straight, compact bundles. These are handed up to the thatcher who works in narrow strakes, occasionally in wider sections, from eaves to ridge, and normally, from right to left.

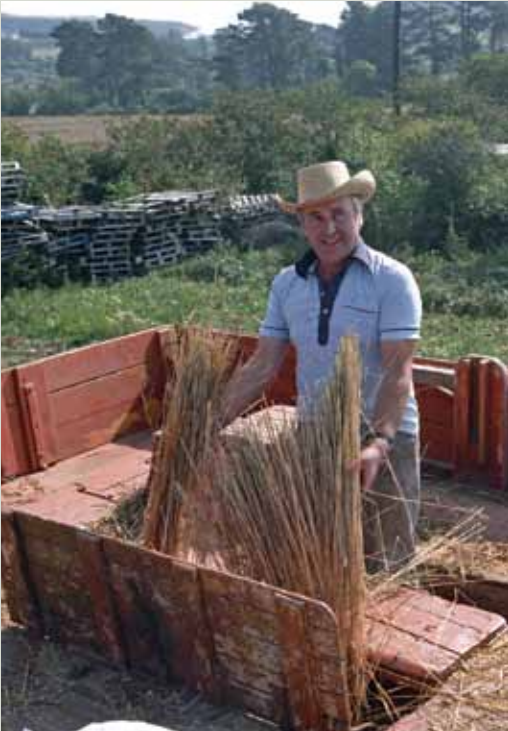
Careful operation of mechanical threshing mills can limit the degree to which the straw is crushed in the process

Thatching straw is best harvested before it is fully ripe when the uppermost nodes of the stem are still green and the straw is still flexible. Cut with a reaper-binder machine, the sheaves are stacked in stooks in the field to mature before being made into larger ricks and threshed in the field. A number of growers use a header-stripper to remove the grain. However, this is unsatisfactory as the straw is generally allowed to ripen more fully to permit this process to be used and the resulting straw is more brittle. Straw can be threshed in a threshing mill which crushes the straw to varying degrees, depending on the skill of the operator. The resulting tangled heap of straw, in which the ears and butts are mixed, should be straightened into bundles or rolled loosely into bales which are more easily transported. Seven or eight rolled bales amount to approximately one tonne of straw. A number of growers employ a threshing drum which threshes only the heads of the sheaves. This permits retention of the original tying which facilitates stacking of the sheaves in a frame and banding together for transport.

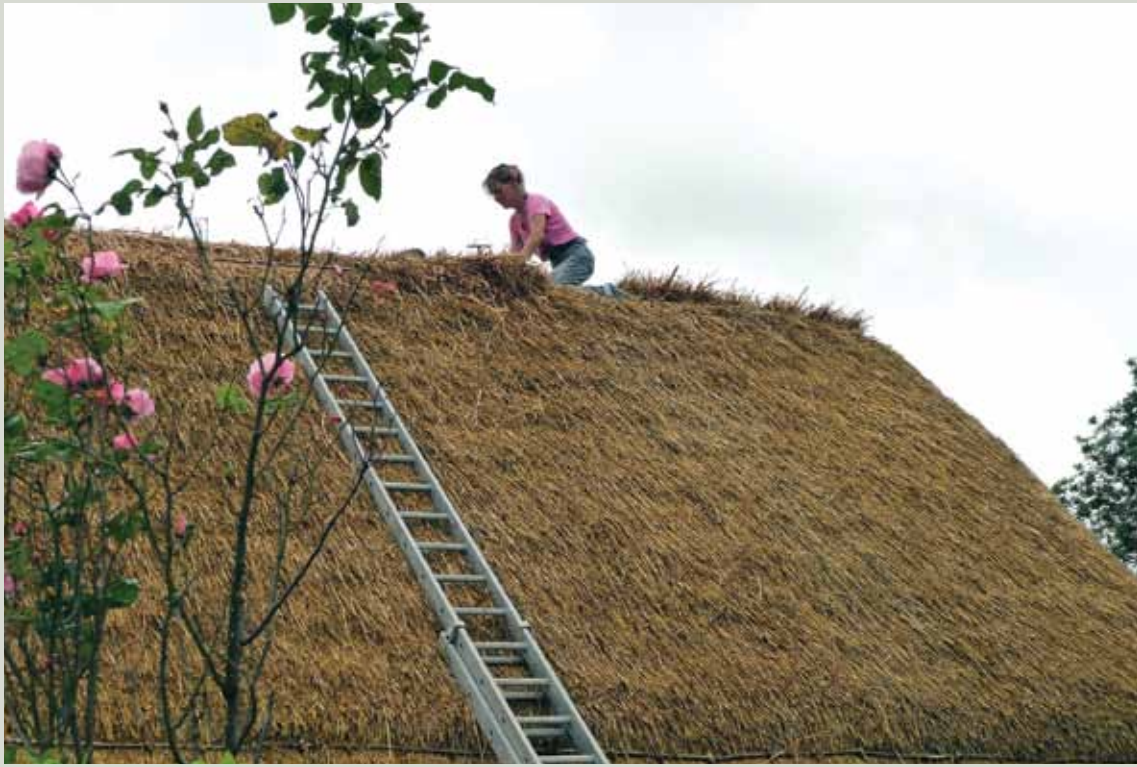
A thatcher at work (Image courtesy of Máirín Doddy)

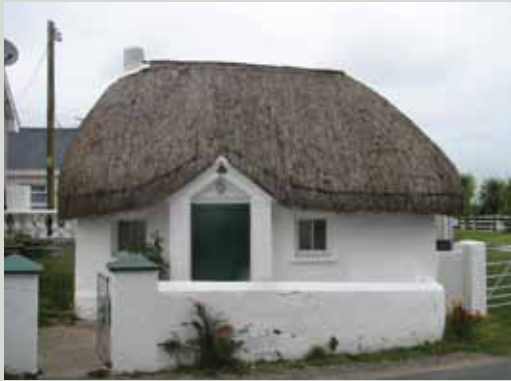
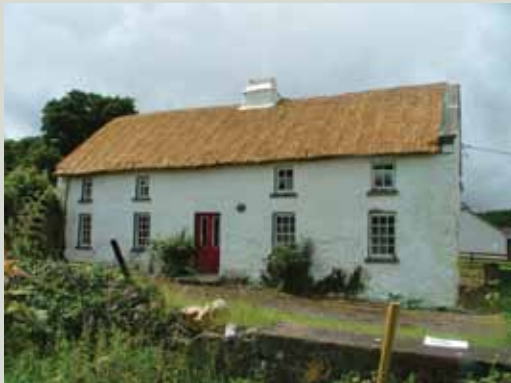
Vernacular houses range in size from a modest two-roomed example in County Wexford to large two-storey thatched 'mansions' such as this one in County Laois. Comparatively few substantial two-storey thatched buildings have survived into the modern era

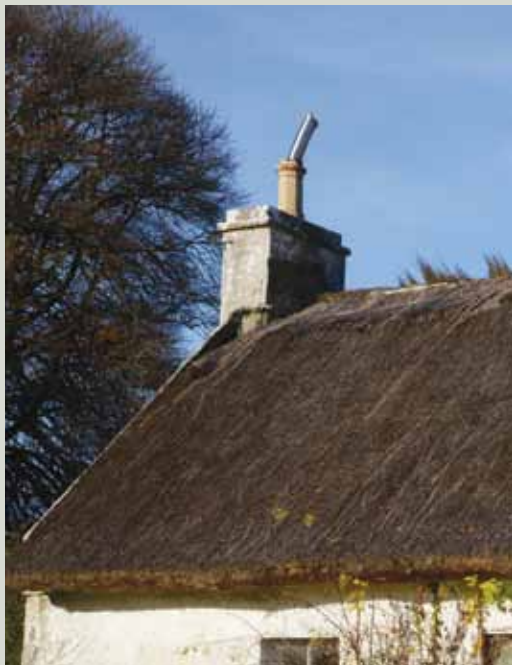
Chimney alterations and flue installations should be carried out by specialist contractors as inappropriate materials and poor workmanship can increase the fire hazard

Nowadays, in the interests of increased energy efficiency, some owners may consider the installation of solid-fuel heating appliances, such as wood-burning stoves, in place of the traditional open fire. However, it is important to be aware that there is a particular hazard in the case of metal flues attached to these solid fuel burners as the flue wall can reach a sufficiently high temperature to ignite the thatch through which it passes. Inappropriate liners and/or incorrect installation can lead to failure. It is therefore essential that chimney alterations and flue installations are carried out only by specialist contractors who are aware of the specific issues and risks relating to thatched buildings. Current building regulations require that where flues discharge on or near roofs with surfaces that are readily ignitable, such as thatch, the clearance between flue and roof should be increased. This may have implications for the character of a protected structure and require planning permission. Alterations to the historic chimney and hearth associated with the installation of a solid-fuel heating appliance may also require planning permission and the advice of the local authority should be sought.

Retrofitting of solid-fuel stoves and flues: There is a particular hazard in the case of metal flues attached to solid fuel burners (see 'Heating' above). The flue wall can reach a sufficiently high temperature to ignite the thatch through which it passes. In addition, insulated flues that are not adequately vented increase the likelihood of unextinguished embers or sparks exiting the chimney top where they may fall onto the thatch.

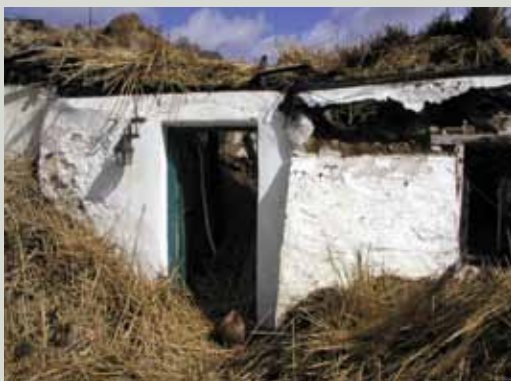
The devastating results of a fire in a thatched building
